TRANSIENT VIBRATION OF LIGHT FRAME FLOORS (PART IV)

A Nash

Charles M Salter Associates Inc, 130 Sutter Street, San Francisco, California, USA

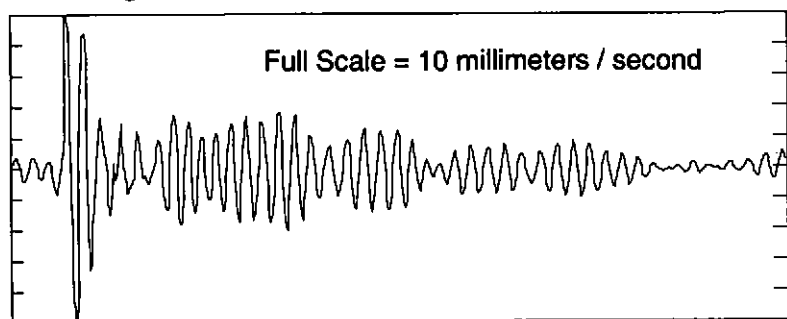
Figure 1: Floor Velocity After Heeldrop

We worked with the structural engineer to conduct several floor vibration measurements using the traditional "heeldrop" test augmented by an electro-mechanical vibration exciter. The floor's response to the "heeldrop" impulse felt like a "bounce" followed by "aftershocks" — a phenomenon observed previously on other long span floors. Figure 1 illustrates eight seconds of floor vibration measured subsequent to a heeldrop. The alternating reinforcement and cancellation (or "beating") of amplitude in the decaying transient is probably the cause of the "aftershock" sensation. This "beating" implies that a number of panel modes having nearly the same frequency are interacting from moment to moment. Clearly, this floor is not behaving like a single degree-of-freedom system.

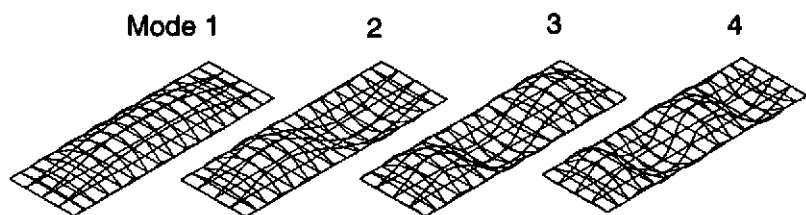
Figure 2: Operational Deflection Shapes

In order to understand the floor system's behavior better, the structural engineer created a mathematical model using a finite element program. Some of the resulting modal frequencies and "operational deflection shapes" of the floor diaphragm are shown in Figure 2. The first panel mode has a frequency of 5.0 Hz. Higher order modes have frequencies of 5.2, 5.4 and 5.8 Hz. If these modes "beat" against one another, the interference pattern would occur at a rate determined by their mutual difference frequencies (i.e., every three or four seconds).

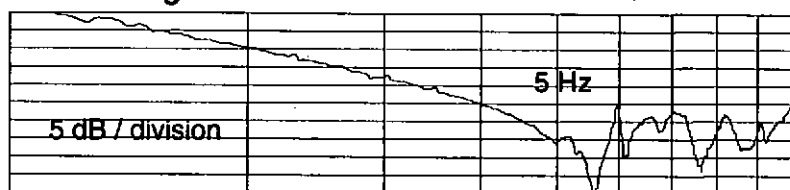
Figure 3: Force vs Acceleration

In order to confirm the model experimentally, we used a vibration exciter to measure a frequency response function at a joist midspan (see Figure 3). The notch around 5.5 hertz is probably a composite of the first several modes predicted by the finite element model. Isolating these modes in the field will require considerable effort as they readily exchange mechanical energy (i.e., the modes are well-coupled).
