VIBRATION ISSUES IN TIMBER FRAMED APARTMENTS CAUSED BY DOMESTIC APPLIANCES

A Parkin and M Evans

Cundall Acoustics

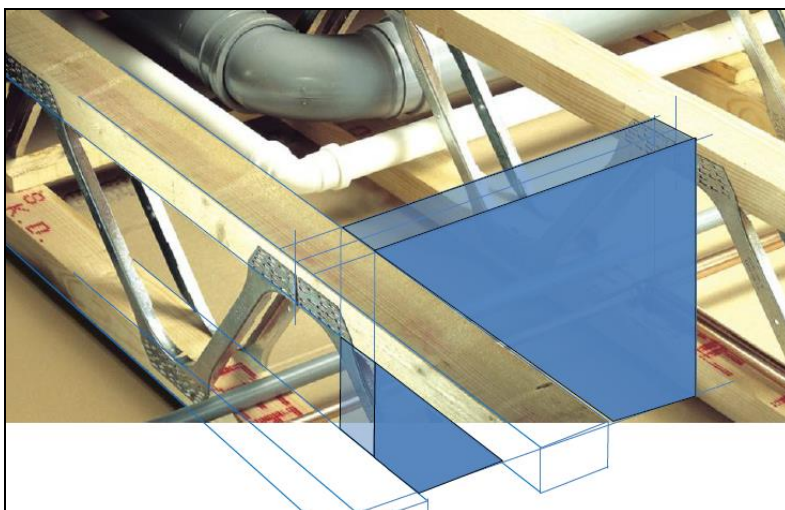
Figure 1 - Stepped blocking detail

The modeling highlighted the structural issue due to the bottom webs of the joists being unrestrained. Although the resilient bars are designed to assist with airborne attenuation, they result in the floor construction being less stiff than if boarding were fixed directly to the underside of the joists. This feature is inherent in a number of Robust Details (e.g. E-FT-3, E-FT-4, E-FT-5 and E-FT-6).

In order to provide increased stiffness within the floor joist zone, stepped blocking was introduced. This involved rigidly fixing timber members between joists in order to provide lateral stiffness. Accommodating this between metal web joists required careful placement to ensure a rigid fixing into the timber trimmers. The diagram below shows the principals adopted.

In addition to the stepped blocking, the ceiling construction was reversed so that a stiff board (OSB) was fixed directly to the underside of floor joists with a resilient ceiling hung below.

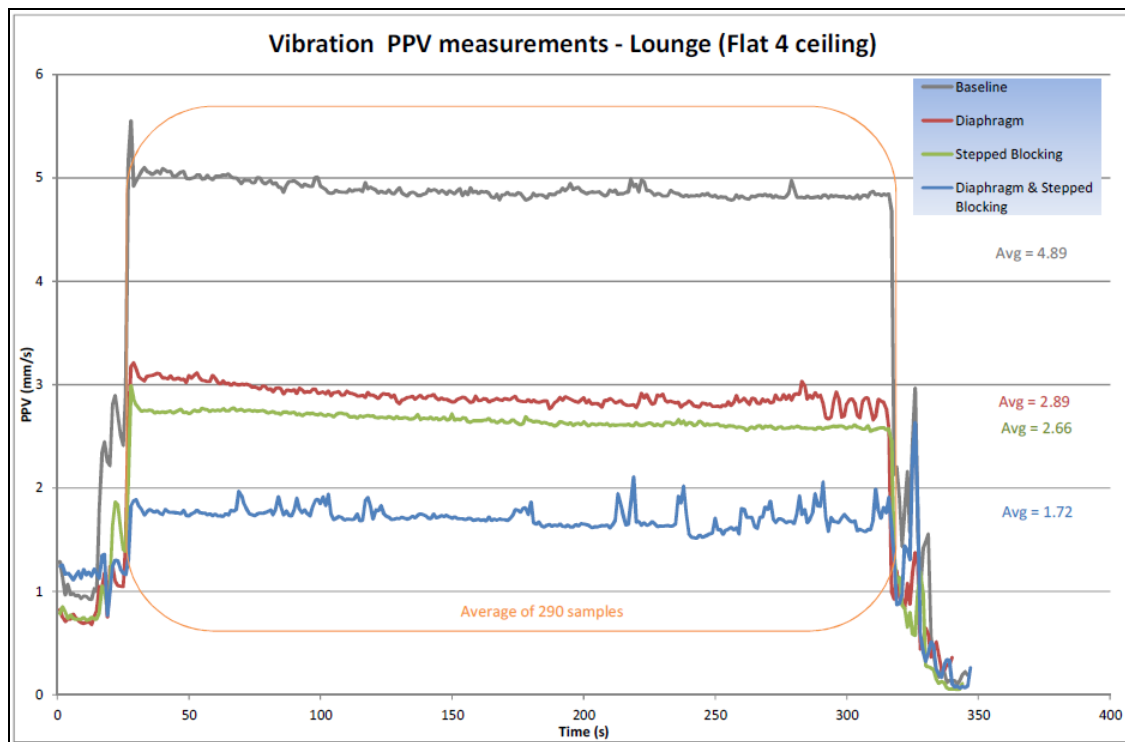
Figure 2 - Results of vibration testing (PPV)

As can be seen from Figures above, the magnitude of PPV and acceleration, when measured on the ceiling of the apartment under the washer/dryer, was significantly reduced by floor stiffening measures. It can also be seen that the greatest benefit was when both stepped blocking and diaphragm boarding were used simultaneously, with a 65% reduction in magnitude when compared with the existing construction.

The following chart shows the baseline condition, then options of step blocking only, diaphragm (OSB) boarding to the underside of joists only, together with the combined effect of both in place. In all cases of the remedial options, this includes an amended ceiling configuration, whereby fire protection is fixed directly to the underside of joists, then a resilient MF-type ceiling installed below.

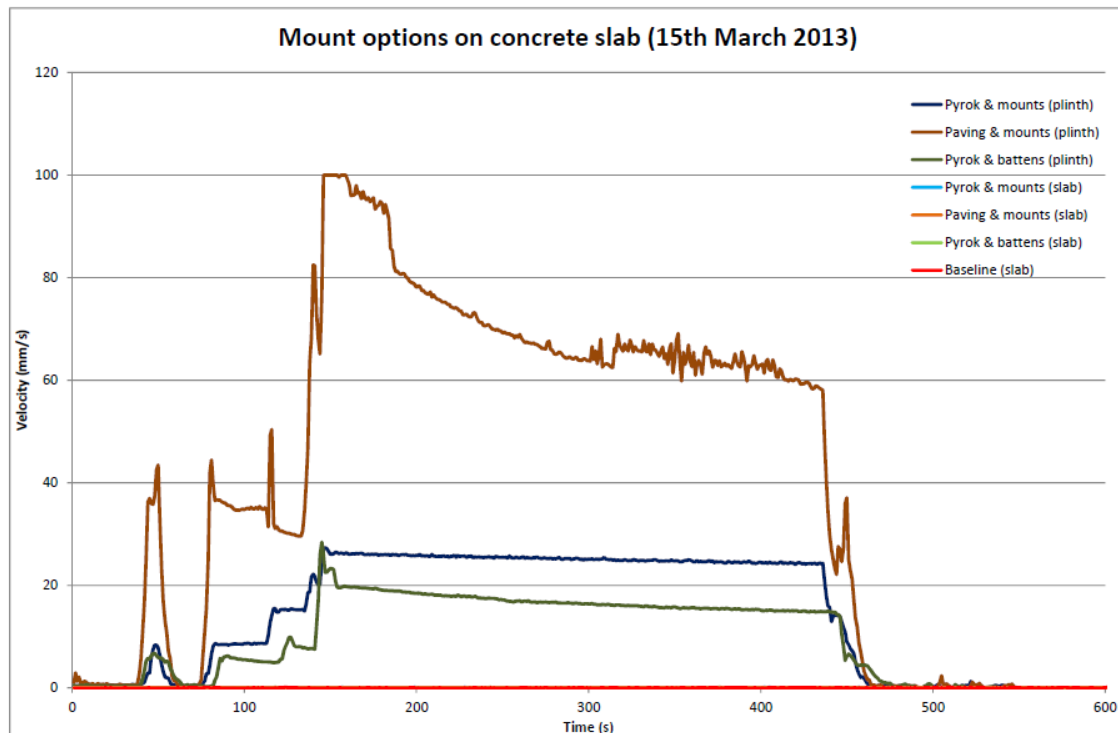
Figure 4 - Vibration tests on plinth (PPV)

The graphs in Figure 4 show results of tests carried out on the plinth containing the washer/dryer.

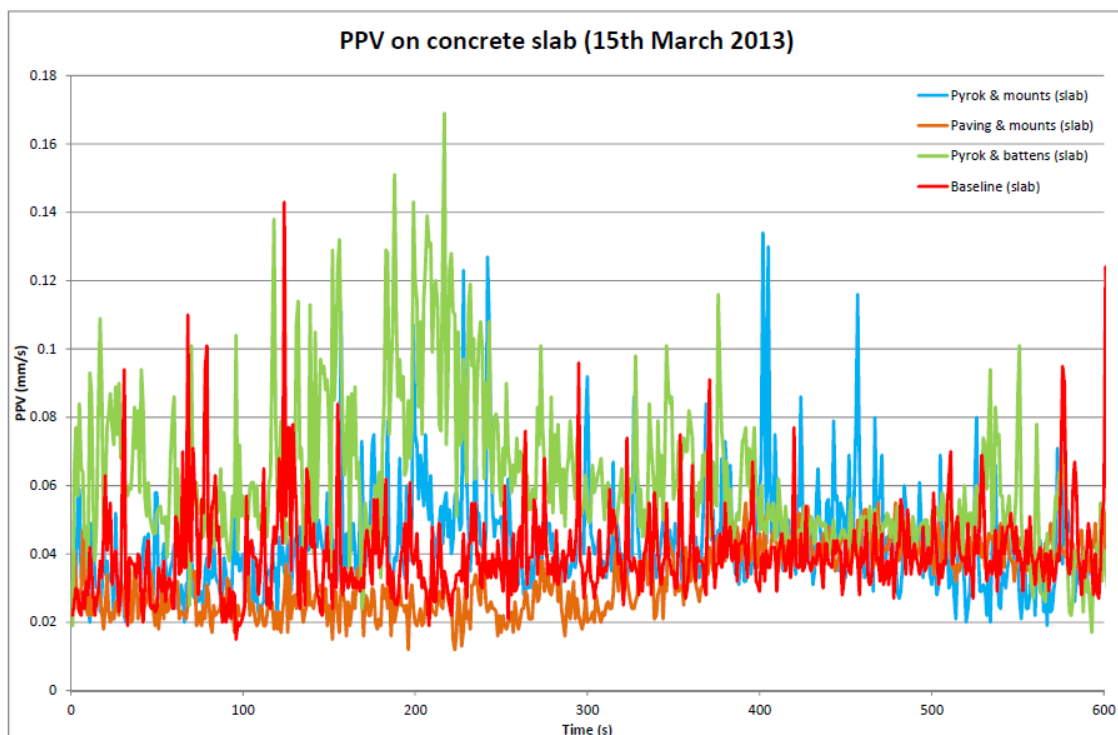
Figure 5 - Vibration tests off plinth (PPV)

The magnitudes of vibration on and off the plinth were so different that it is not possible to display both on the same chart. Figure 5 shows the transmitted levels of vibration.

As can be seen, the solution that allowed the greatest magnitude of vibration on the plinth (i.e. paving slab with rubber mounts) also transmitted the least amount of energy into the structure. The extract below shows the final mounting solution.

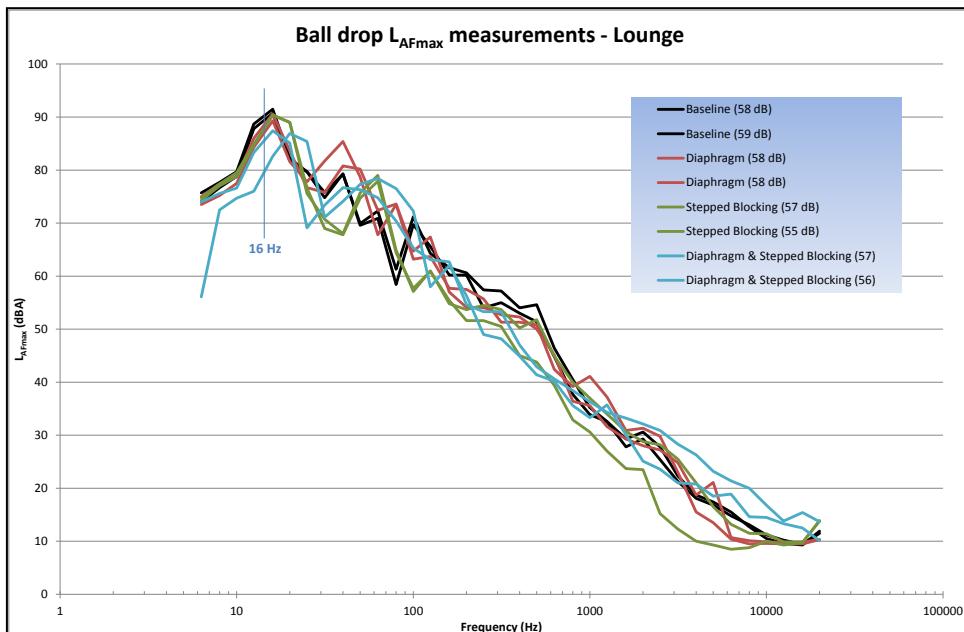
Figure 7 - Ball drop test results

As can be seen, stiffening the floor did make some improvement in the low frequency performance, and depending on the location on the floor under test, the main excitation frequency was shifted slightly upwards.

The conclusions drawn from this were that stiffening of the structure alone would not be sufficient to improve residents' reaction to low frequency impact noise transfer.

In order to better control impact noise at source, rather than its resonance within the structure, the next step is to trial rooms with the screed removed and replaced with a cradle and batten timber flooring. This will provide significantly more isolation from footfall energy, with the intention of reducing the inherent 'boominess'.
