# Proceedings of the Institute of Acoustics

## ACOUSTIC CONDITIONS OF THE SAN FRANCISCO WAR MEMORIAL OPERA HOUSE AND ITS RENOVATION

Dennis Paoletti (1), Kurt Graffy (2), Larry Tedford (3)

Paoletti Associates, Inc. San Francisco, CA, USA

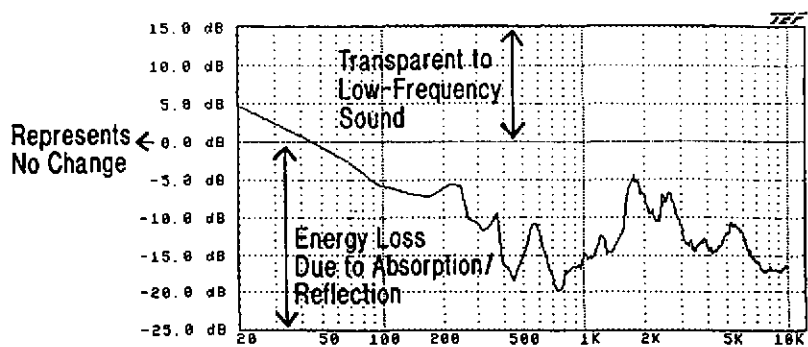
In their current form, the organ loft and the grille openings are "frequency selective" (see Figure 2). Depending upon the location of the sound source, the frequency (more accurately, wavelength) of the incident sound, and the particular organ bay position evaluated, some energy will be reflected (and/or scattered) by the grille and returned to the room, and other energy will be admitted into the organ loft through the grille and the velour drapes. The energy which is transmitted through the grille may be considered "lost" or absorbed from the energy within the hall. While the existing loft space can be considered a semi-coupled volume to the main house, the effect of changing the overall volume of the loft has an undetectable effect on the overall reverberation time in the main house, due to the immense volume of the audience chamber.

Our measurements for the organ loft were conducted to determine the sound energy reflection and absorption characteristics provided at the organ bay openings. We carried out a series of measurements with the TEF analyzer, measuring the sound energy on both sides of organ loft grilles (this was done for each of the three bays, house left side). We then evaluated the change between the direct sound incident to the bay openings, and the sound which actually passed into the organ bay.

The accompanying graph represents the averaged frequency response difference for the 3 house left organ bays. The Y-axis represents amplitude in decibels and the X-axis indicates frequency in Hertz plotted on a logarithmic scale. The "0" decibel line represents unity, indicating that there was no measured change between the sound energy measured at the front of the bay opening to that measured behind the curtain. This means that the sound was neither reflected by the grille nor absorbed by the curtains. This is more apparent in the lower frequencies, which due to their long wavelengths, respond to the loft openings as if the grille work was non-existent. At mid and high frequencies, the openings act as a frequency-selective absorber and reflector caused by the size of the grille openings and surface variations.

Figure 2 Frequency Response Difference - Organ Bay Grilles

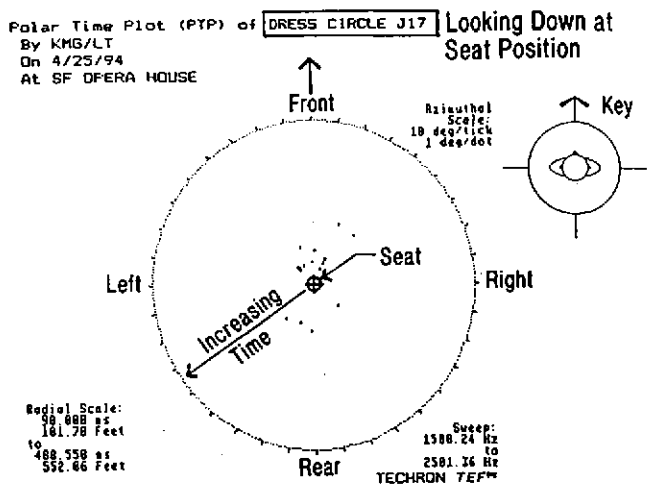
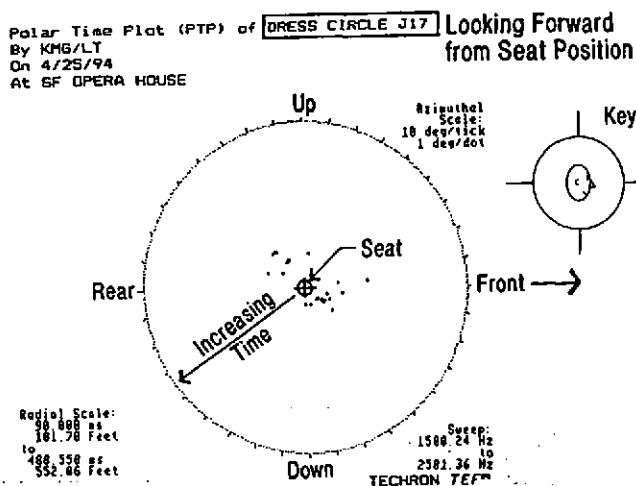
**Dress Circle Shearwalls.** Concrete shearwalls will be added at the side/rear of the Dress Circle seating area. From an acoustical standpoint, the shearwall will serve to place a hard sound reflective boundary surface closer to audience seats than presently exists. To determine the acoustical significance of this proposed construction, and to help provide future recommendations with regard to possible architectural finishes, we conducted Polar ETC measurements at a representative seating location (seat J17) near the proposed shearwall (see Figure 3). The accompanying figures provide a graphical representation of the significant reflected sound energy arrivals and their relative time offset in both the horizontal and median planes.

Our analysis looked at the direction, time difference, and relative strength (or amplitude) of sound energy reflections relative to the direct sound. Significant sound reflections from behind the listening location arrive approx. 85 milliseconds or more after the direct sound, thus contributing to the "definition" of the sound source. At this particular seat, the primary reflective energy comes from the wall corner cove formed by the entry door and the ceiling. A smaller amount of sound energy comes from the back wall due to the reduction in exposed wall area caused by the angle and seating rake of the Dress Circle. We anticipate that adding the shearwall will cause the reflected sound to arrive earlier in time to the listener (since the shearwall will be closer in distance), and at a higher amplitude.

Although this increased energy return from the wall surface will not be detrimental to the clarity of the direct sound, it will present a change in both the sound level and the directional impression.

**Figure 3** Polar Energy Time Curve

We recommended that the face of these shearwalls from at least ear height (or seat back) to the ceiling be treated with a sound-diffusing acoustical treatment. Such treatment will maintain the useful early sound energy (as opposed to using an absorptive finish which would greatly reduce reflected sound) but will "scatter" the reflected sound. This will reduce the increased intensity of the reflected sound while maintaining the general spatial impression which exists in the nearby seating area.
