# Proceedings of The Institute of Acoustics

## MONITORING THE EFFECTS OF SIMULATED ROAD TRAFFIC VIBRATIONS ON A TEST HOUSE - RESULTS

C Marshall and R A Hood

Travers Morgan Planning, East Grinstead, West Sussex

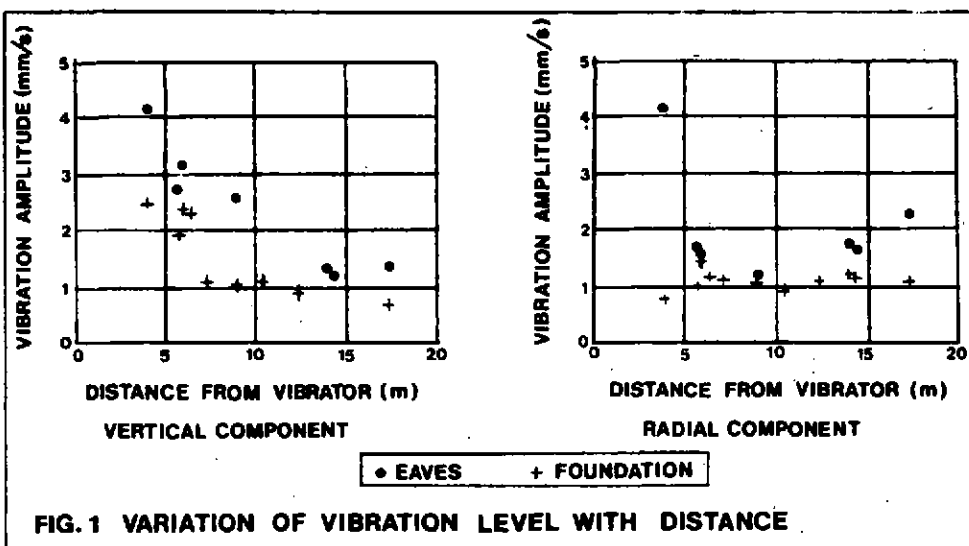
FIG.1 VARIATION OF VIBRATION LEVEL WITH DISTANCE

The vibrations of the front facade of the structure in vertical and radial directions, with respect to the vibrator were studied. The peak levels measured are plotted on Fig.1.

On the foundations the vertical component attenuates with distance approximately in accordance with an inverse square root function. The pattern is mirrored at eaves level with some amplification, which is probably associated with the reduced dead load. This smooth response is unlikely to have introduced any severe stress concentrations into the structure.

The radial component demonstrates a very different pattern of behaviour. On the foundations, no significant attenuation is present. At eaves level, vibration peaks at either end of the structure, with a drop in level towards the middle. This pattern suggests that the main transmission of energy is taking place through the foundations.

At eaves level there is a large change in radial vibration level between the end of the structure and the adjacent measuring position. The restraint afforded by the chimney is probably a major cause of this. Such a sudden change in vibration level is likely to be associated with stress concentration.

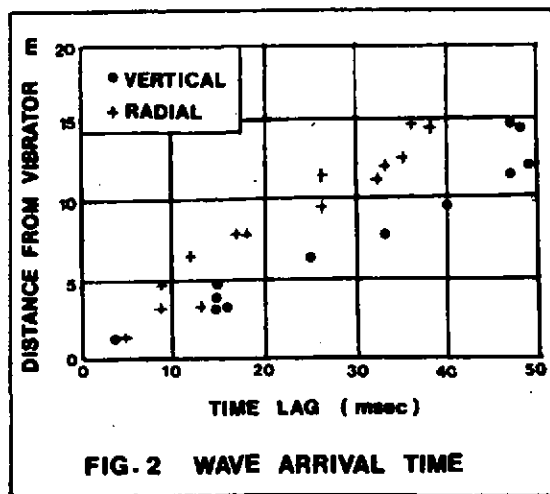
FIG.2 WAVE ARRIVAL TIME

Fig.2 plots the time taken for the wave front to reach each geophone station against distance from the vibrator. This shows the radial component to be travelling approximately 25% faster than the vertical component.

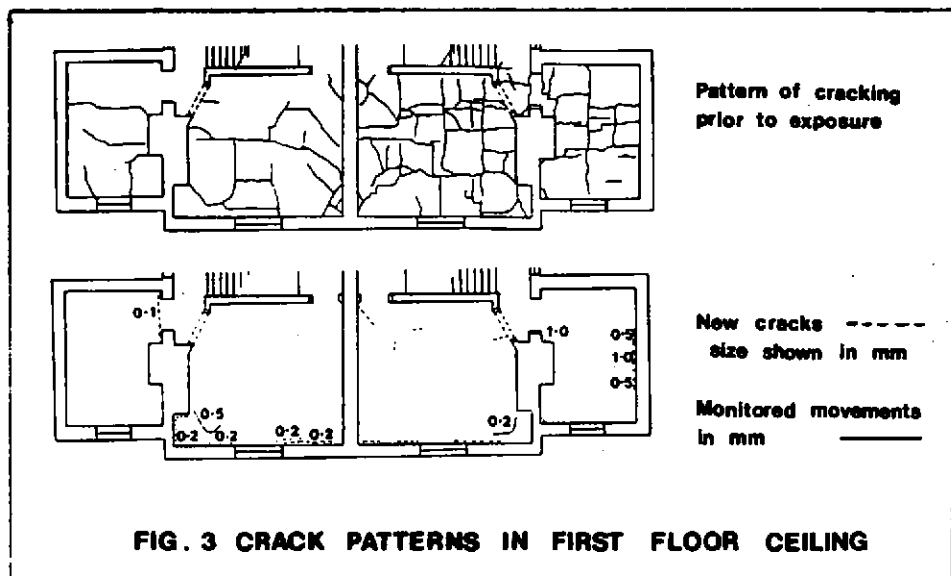
A small amount of additional cracking of plaster occurred during the experiment, mostly at wall/ceiling junctions. Of the 40 existing cracks surveyed for movement, only 5 showed a sustained change in width exceeding 0.1mm. First floor ceiling crack patterns are shown on Fig 3.

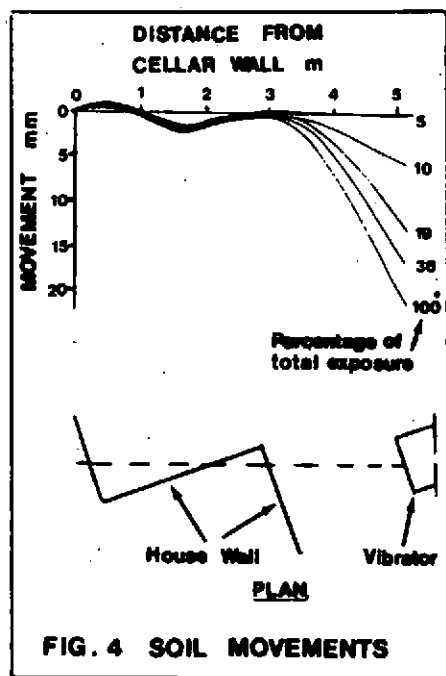
Although a settlement of 22mm was recorded within the soil under the vibrator pad, little movement was evident beneath the house foundations. Figure 4 shows the movements recorded by one of the electrolevel strings. In contrast, settlements in the range 1-11 mm were measured on the test strips. The pattern of these settlements is shown on Figure 5.

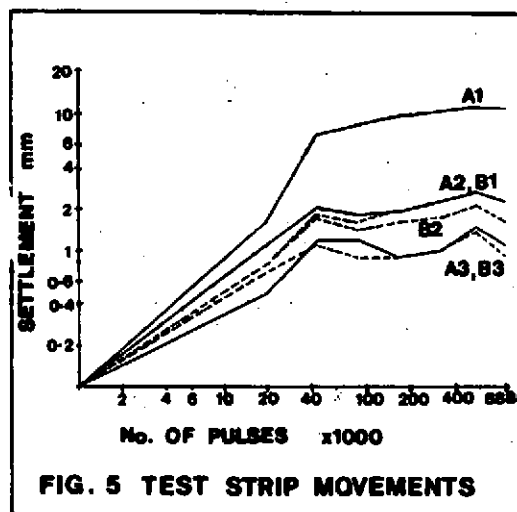
All six test strips tilted to some degree. In each case, two levelling stations were monitored. The settlements measured are tabulated below:

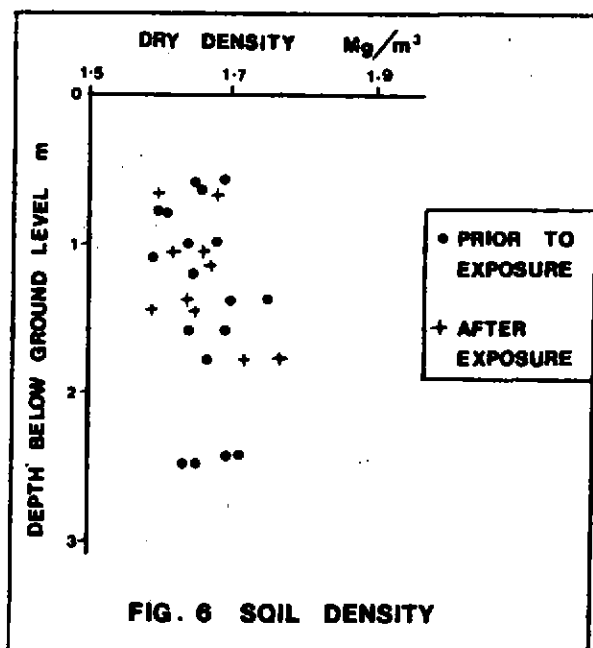
At the end of the experiment, a second site investigation was conducted, to assess the density of the soil beneath the vibrator the house foundation and the test foundation strips. In all locations, the measured densities fell within the range assessed for the site prior to the simulation. (See Fig.6).
