EXPERIENCE IN THE USE OF VIBRATION HEALTH MONITORING TECHNIQUES ON CENTRIFUGAL FANS

E. J. WILLIAMS¹ AND N. R. FRAJBIS²

²ALLIED BREWERIES LIMITED

Allied Breweries' new plant at Mistley will produce 22,000 tonne of malt per year; 25% of the company's malt production, and went into operation in March 1977.

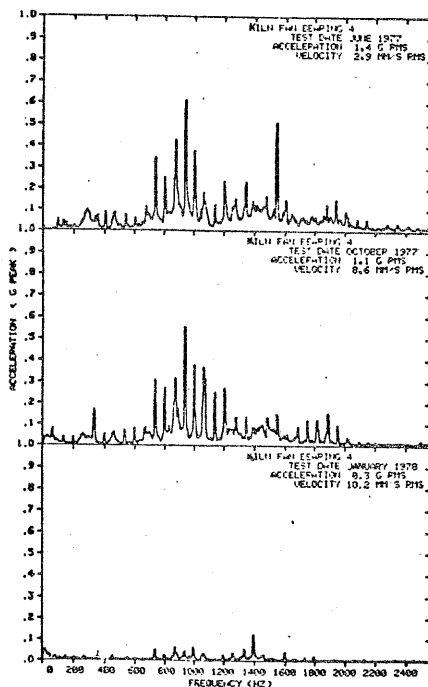
When the bearing was removed for examination in April 1978, significant surface damage was found on the outer race. Due to the propagation of sub-surface fatigue cracks, spalling had occurred on two patches of 2-4 cm² spaced a roller pitch apart. One and two roller pitches further on, more surface damage was present, although no metal had broken away. The spacing suggests strongly fretting induced fatigue.

The acceleration spectra (fig.1) have a pattern consisting of a set of uniformly spaced peaks suggesting strongly an association with one of the characteristic frequencies of the bearing elements. The spacing agrees closely with the frequency (63-64 Hz) of the rollers striking an isolated defect on the outer race.

Fig.1 : Acceleration spectra for
kiln fan bearing No.1
