RESPONSE OF BUILDING ELEMENTS TO SIMULATED TRAFFIC VIBRATIONS

G.R. Watts

Transport and Road Research Laboratory, Crowthorne, Berkshire

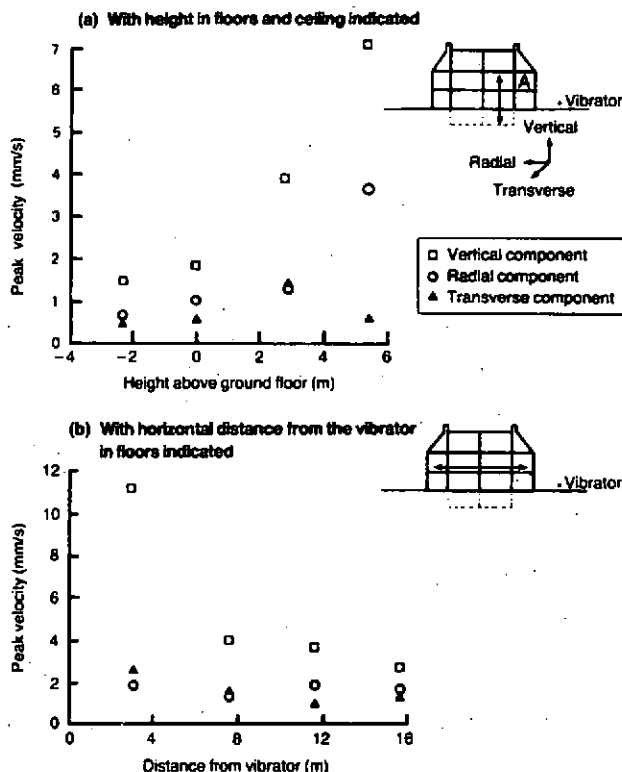
Investigations showed that the response of the building to groundborne vibrations was complex. This was partly due to the fact that the building was not subject to plane waves since the vibrator was positioned only 2 m from the side wall. In addition the forcing frequency was not purely sinusoidal since it included a number of significant harmonics (see figure 1(b)). As expected it was found that suspended wooden floors and ceilings were among the building elements showing the greatest response. Triaxial measurements were made in the middle of floors, on roof joists and on the floor of the cellar. Figures 3(a) and (b) show the variation of vibration level between the various measurement positions. There is a clear trend of increasing level with height for both vertical and radial components which is likely to be due to the decreasing dead load and restraining influence of the ground and changes in the mass and stiffness of the suspended floors. Although vertical levels decay rapidly with horizontal distance, radial and transverse components do not. It appears that vertical shear waves are more greatly influenced by the damping in the underlying soil. Levels on the external brickwork of the front facade followed broadly similar trends although absolute levels differ.

Fig. 3. Variation of peak particle velocity on floors and ceiling joists

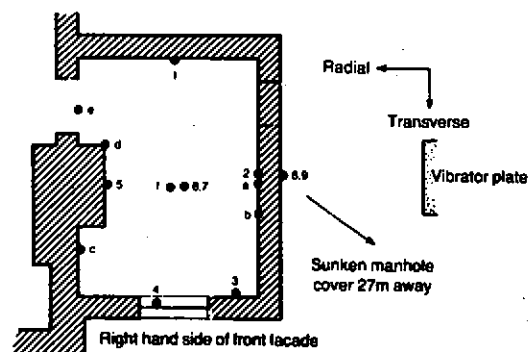
The highest levels were recorded in the first floor room adjacent to the vibrator where the most obvious damage to the building occurred. This was limited to a number of hairline cracks in the lath and plaster walls and ceiling and a small piece of loose plastic was dislodged. No structural damage had occurred. Figure 4 shows a plan of this room which is labelled A in figure 3(a). Numbers 1 to 9 and labels a to f refer to geophone and strain gauge monitoring positions respectively. Tables 1 and 2 list the peak velocities and crack movements that were recorded. It can be seen from table 1 that the highest levels occurred on the window pane and in the middle of the ceiling.

The vibration level on the chimney breast (position 5) was substantially less than on the opposite wall (position 2) and this was probably due to the high mass and stiffness of this structure. These vibrations were in phase and because of the difference of velocity (4.1 mm/s) a maximum displacement of 50 microns was expected across the ceiling on each cycle. Strain gauge measurements showed that virtually all this movement was accommodated at two cracks

(d and f) one of which had developed during exposure (see table 2). These were the highest measured crack movements in the building.

Fig. 4. Location plan of first floor room near vibrator

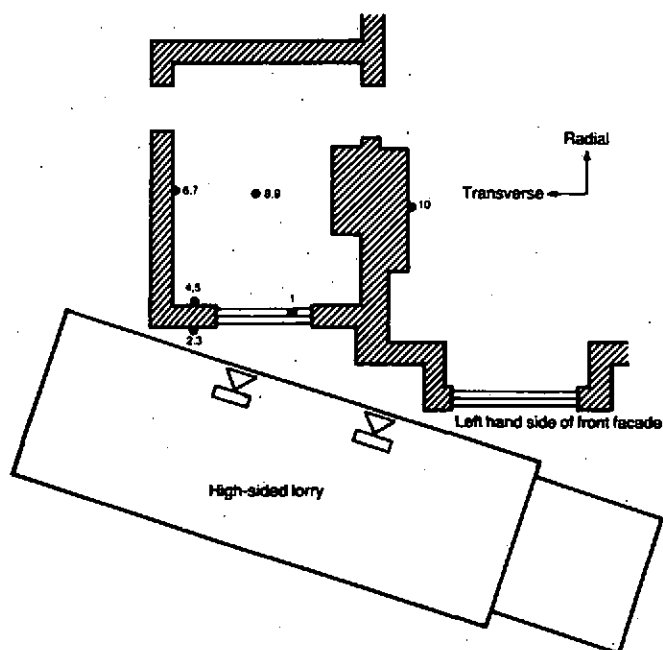
Table 3 lists the peak levels of vibration in rooms most affected by the airborne vibrations (see figure 5).

The linear sound pressure levels measured at a height of 1.2 m above the middle of the ground and first floor rooms were 98.6 and 89.5 dB respectively. The ground floor responded poorly due to the restraining influence of brick sleeper walls under the joists. The peak level on the suspended floor above was nearly 2.5 mm/s due to the fact that its natural frequency was close to the driving frequency. The highest level of over 130 mm/s was produced on a ground floor window pane. This was expected since the source was adjusted to obtain resonance. Comparing levels at points 3 and 4 on opposite sides of a wall it can be seen that the lath and plaster responded more to airborne vibration than the much stiffer brickwork. Vibration levels produced by the acoustic source in other rooms were barely perceptible unlike the levels produced by the vibrator. For example the level on the chimney breast in the adjacent room was only 0.18 mm/s.

Fig. 5. Location plan of ground floor near noise source
