K Dibble, Ken Dibble Acoustics (Rugby, UK)

NICE OFFSHORE - A CASE STUDY IN DISCOTHEQUE NOISE CONTROL

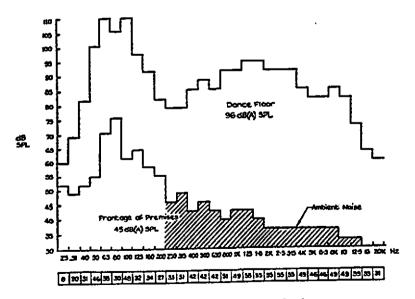
The lower curve of Fig #1 shows the residual noise outside a premises. Note that whilst the building facia provides adequate attenuation at mid and high frequencies, this does not hold at LF, leaving that pronounced bass beat clearly audible outside. This is because the Mass Law:-

Fig. 1 Typical Discourague Noise Spectra Inside & Outside Premises

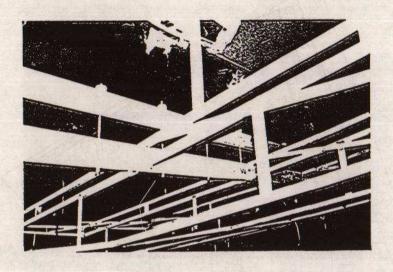
Fig 4

This is an extremely complex affair whose conceptual and engineering integrity can only be admired and which must have cost hundreds of thousands of Francs to erect. It essentially comprised a series of steel lateral trusses some 2m below the original fibrous plaster ceiling, spaced between 3.5m and 5m apart, rigidly attached to the structural roof joists by means of steel spars, each with a secondary truss suspended under it by 10mm steel studs carried by proprietary isolators mounted across its upper face. Fig #4 shows the general arrangement.

The floating floor was repaired and the perimeter gap cleared of rubble, sections of bridging screed removed and the floor made good and extended to include the stage area. Similarly, the isolated ceiling was refurbished by dismantling, checking and re-aligning the isolator units, enlarging the clearance holes so Proc.I.O.A. Vol 14 Part 4 (1992)
