## REMEDIAL MEASURES FOR TIMBER JOIST FLOORS

S J Flynn, B R E Advisory Service, Building Research Establishment.

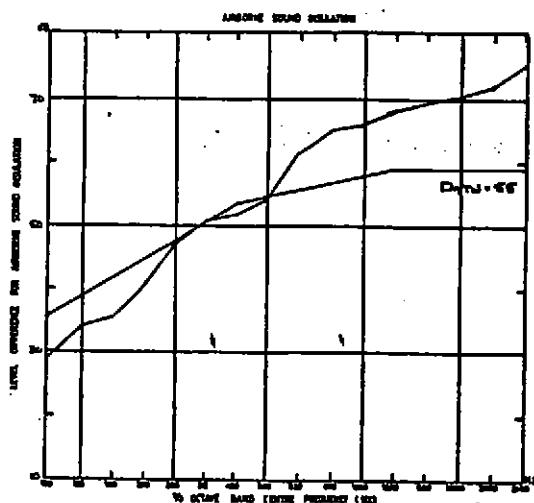
fig. 3.

Timber Frame  
Construction.  
Floor: Floating  
Chipboard layer  
19 mm. Plated.  
(Plank) on  
25 mm fibre  
quilt, paper  
faced.

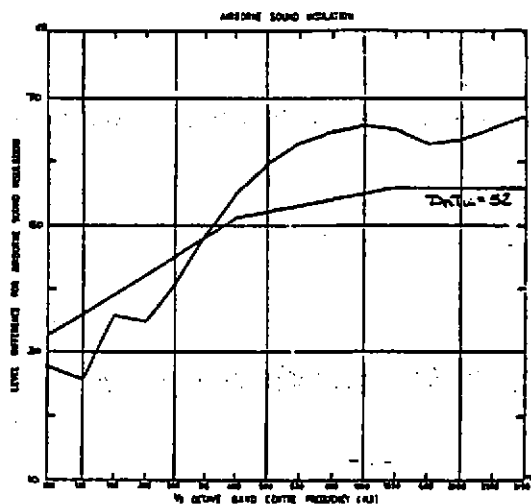
fig. 4

Asbestos sheet  
but with hard  
felt and insulating  
laying paper  
added.

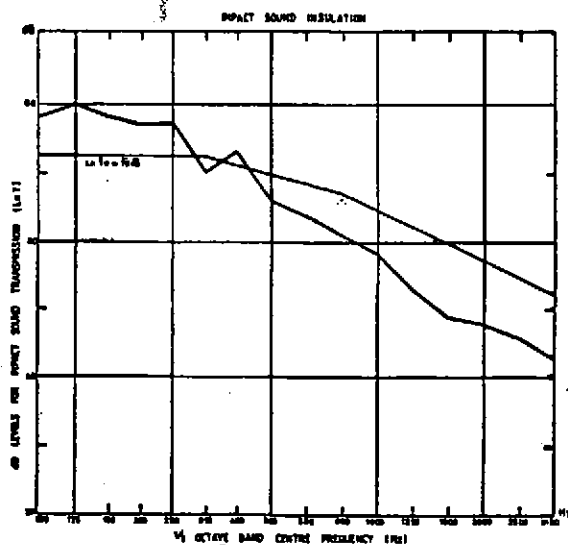
In this example, the builder nailed through battens of a floating floor construction fixing it to the floor joists. The lounge floors in these rooms were of very large dimensions and the effect was horrendous, but because of furniture problems, measurements (figs.9&11), were only possible in the small kitchen areas. The results were therefore favourable to the 'nailed' condition, but when the nails were removed the improvements (figs.10&12) were disappointing partly because 'spiking' was used to locate the battens and also because the mass of the floor was not high enough.

Heavy Masonry.  
Conversion to  
Floating Floor  
on Rubber or  
Polypropylene.  
Battens nailed  
through to joists  
by 4" nails.

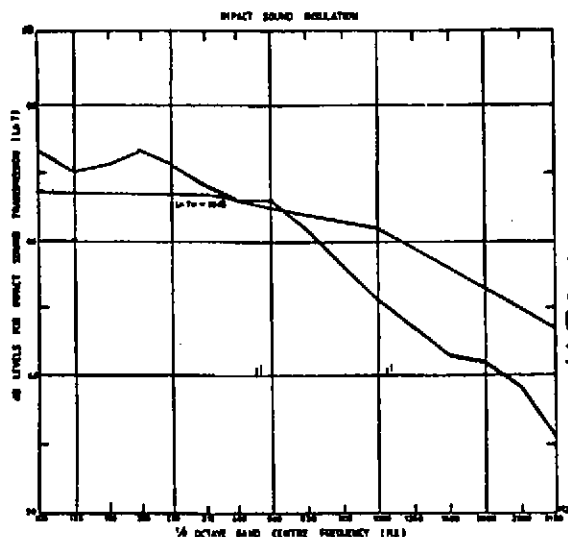
Heavy masonry:  
Conversion to  
Floating Floor  
on Rubber or  
Polypropylene  
Battens located  
along joist by  
spikes in oversize  
holes.

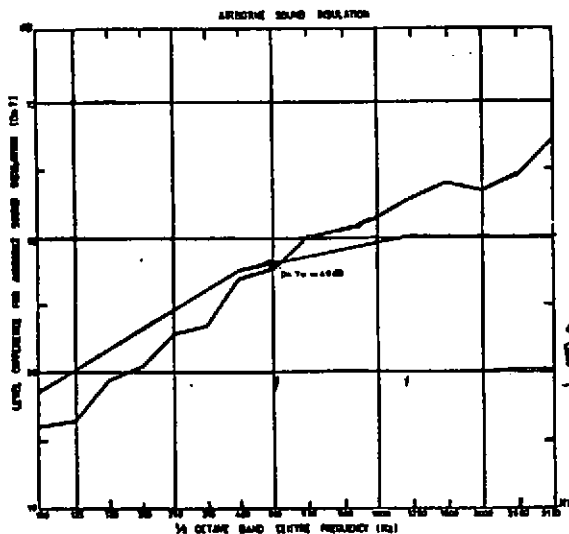
fig 11

Heavy masonry:  
Conversion to Floor  
Floating on Rubber  
or Polypropylene.  
Battens NAILED  
through to joists  
by 4" nails.

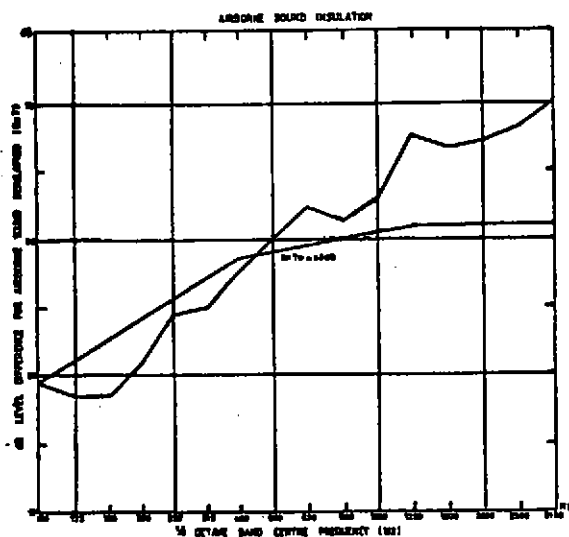
fig 12.

Heavy masonry:  
Conversion to  
Floating Floor  
on Rubber or  
Polypropylene.  
Battens nailed  
along joists by  
spikes in oversize  
holes.
