Proceedings of The Institute of Acoustics

SOUND INSULATION IN REHABILITATION TENEMENTS, GLASGOW

W.N. Hamilton and R.K. McLaughlin

Building Acoustics Group, Glasgow College of Building and Printing,
60 North Hanover Street, Glasgow G1 2BP

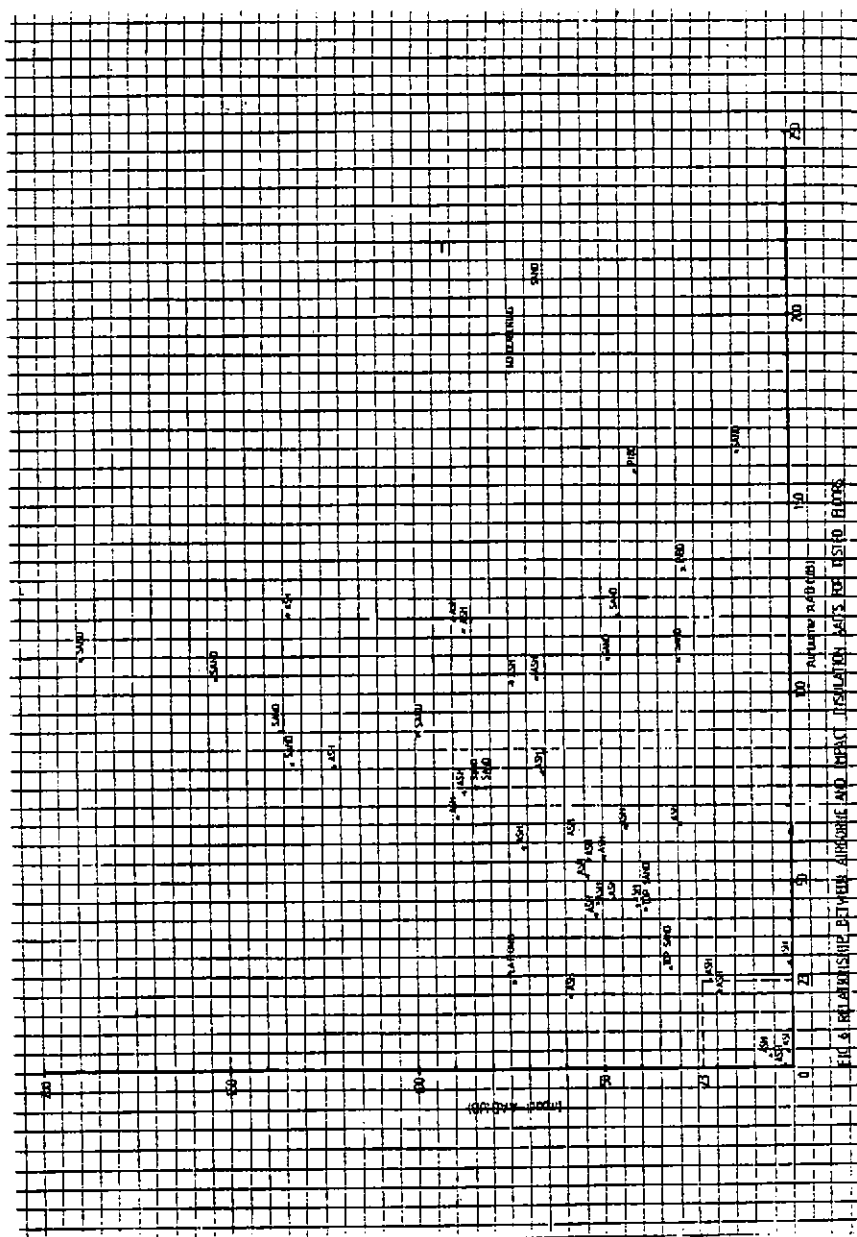
The Group tested several sand or sand/ash specifications and generally found them to be unsatisfactory. Several of these test results are identified in Figure 6.

The Group has tested a small number of ash deafened floors, (deep-joisted) with lathe and plaster ceilings and deep cornices, in situations where there has been little or no disturbance to the floors, mainly in residential property. Sound insulation performance on both airborne and impact tests has been good as can be seen with reference to Figure 6.

Tests have also been undertaken in tenement properties on ash deafened floors in situations where floorboards had been lifted some years ago to allow the upgrading of electrical and sometimes gas and plumbing services. Figure 6 shows a cluster of airborne/impact points indicating poor performance of such floors.

The Group has found that where floors are disturbed for rotwork replacement and sand is used to replace ash over that portion of the floor, the impact/airborne performance (again see Figure 6) has been poor.

In cases where the floor is completely disrupted and 100 percent replacement of ash with sand has been carried out the results (Figure 6) have once again been disappointing.

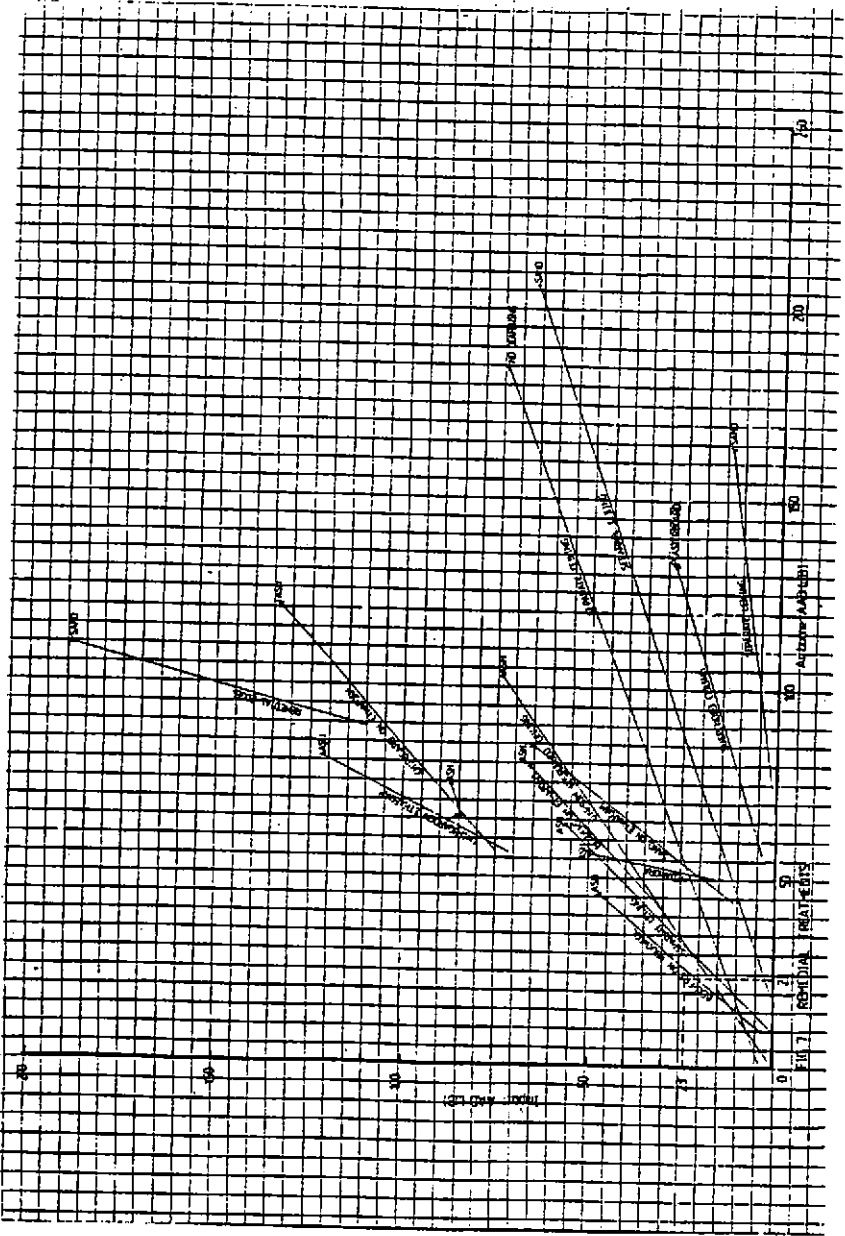
Figure 8. In many apartments 100 mm by 50 mm joists will suffice for the under ceiling. Windows can be a constraint on the depth of the cavity but generally in tenements, ceilings are high and often a depth of 300 mm or more is available. The major disadvantages appear to be the amount of disruption to the tenant and the cost of installation. The Independent Ceiling has proved to be the most successful solution for the tenement timber floors, as indicated in Figure 7.

This option was explored as an alternative to the independent ceiling in terms of cost savings for timber. Typically the 100 mm by 50 mm joists are replaced by a 50 mm by 50 mm frame which is suspended from the existing ceiling. Care must be taken with resilient disconnection on the support (see Figure 9). The disruption is about the same as for independent ceiling and from a buildability point of view it is not so good. The results (Figure 7) are good but not so dramatic as the independent ceiling.

This broadly has taken the form specified in the literature [2] and also in Figure 8. It is more suited to the rehabilitation rather than the maintenance process and has been reasonably successful as indicated in Figure 7. It adds mass and resilience to the floor and may well improve edge sealing and hence air tightness. The major disadvantage is that the floor is raised and this involves adjustments of skirtings and doors.

More recently the Group was called by a local housing association to pretest 7 floors in two sets of flats with traditional ash deafened floors, then return to retest after modifications involving a range of specifications had been carried out. Despite the limitations imposed on this exercise by the variability of 7 different room configurations some useful information was gleaned from the project. Room plans and floor specifications are shown in Figure 8 and the airborne and impact data are included in Figure 7.

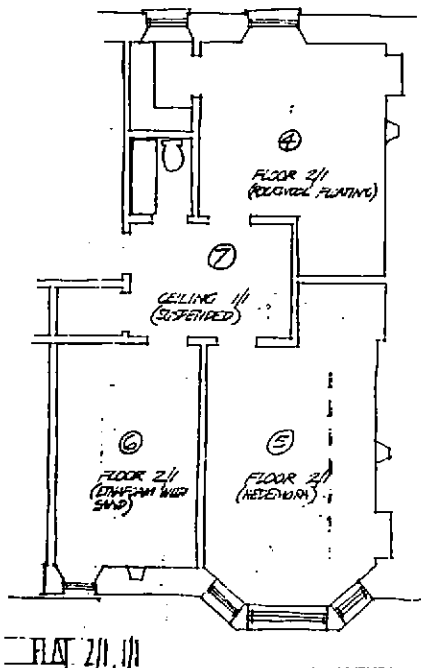
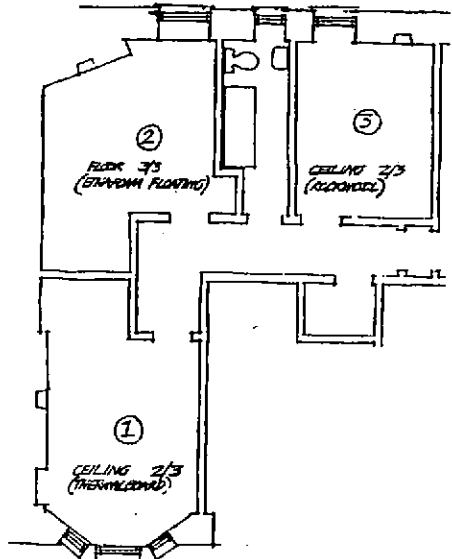
FIG. 8

Similar to the Top Surface Sand Specification in that resilience is added and air tightness improved with a small addition of mass. The same constructional disadvantages apply as with sand but there could well be circumstances where this solution would be preferred to that employing sand between the battens.

The same beneficial mechanisms appear to be at work here as with Detail 2.

This was a proprietary material consisting of two thin boards separated by a viscoelastic layer, laid on top of the existing floor. The advantage is that there is little increase in floor thickness and the disadvantage is that little mass has been added to the floor. There is little significant reduction in the airborne AAD but significant reduction in the impact AAD.

Comments as per Top Surface Sand still apply here.
