A STUDY OF THE DAMAGING EFFECTS OF ACOUSTIC SHOCK WAVES FROM A “CONTROLLED” EXPLOSION ON NEARBY BUILDINGS

Alok Bhattacharyya and Gordon Hunter

Faculty of Science, Engineering and Computing, Kingston University, KT1 2EE, UK

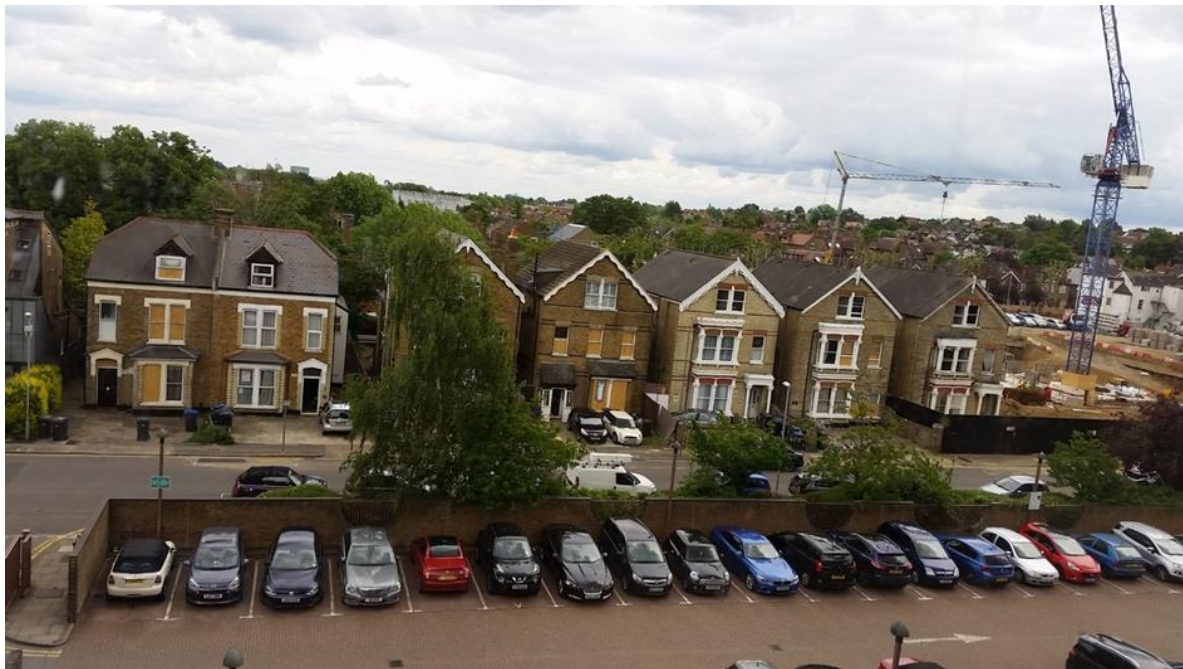
Figure 2 : Photograph of the area of the bomb site, taken a few days after the detonation, showing boarded-up windows which had been damaged as a consequence of the bomb's detonation on houses on Fasset Road, immediately to the North of the bomb's position (close to the blue crane on the right of the photograph). The pattern of damaged and undamaged windows is discussed below. Very few windows in houses to the South of the bomb's position were damaged, and those which were damaged on that side were all in direct "line of sight" from the point of explosion.

Moving North along the road from the position where the bomb was detonated, it was observed that first building had no damaged windows. The second building had its top left and top middle windows on the first floor damaged (see Figure 2). The third building showed no damage, but the fourth building had damaged windows on the first floor and damaged windows or doors on the ground floor. The fifth and sixth buildings showed no damage as far the glass doors and windows were concerned. The seventh building showed damage to windows on the ground floor, on the left side of the first floor and to the attic window. This pattern of damaged and undamaged buildings cannot easily be explained in terms of direct "line of sight" shockwaves – they are blocked from direct line of sight from the point of the explosion by the fabric of the buildings themselves - but is instead analysed in terms of multiple specular reflections off the walls of the buildings on either side of the road (see Figure 3). In contrast, to the South of the bomb's position, only buildings to the in direct "line of sight" of the detonation position showed any obvious damage. On the South side, no long plane walls were present to allow the multiple specular reflections of the shock ways which were observed to the North of the point of detonation. It should be noted that all windows in the University's Sopwith building to the West (right hand side of map images) were opened prior to the bomb being detonated, to mitigate against the effects of the shock wave from the explosion.

In this analysis of damaged caused by the controlled explosion of the 250kg World War II bomb discovered and detonated in Kingston upon Thames in late May 2019, an actual photograph was used to identify houses with damaged glass windows and doors, and these were located on an Ordinance Survey map of the area that showed the place of detonation and other surrounding buildings. Ray tracing was used following laws of specular reflection to show how pressure wave initiated by detonation could have caused the damage observed in the locations it occurred, and where no damage occurred.

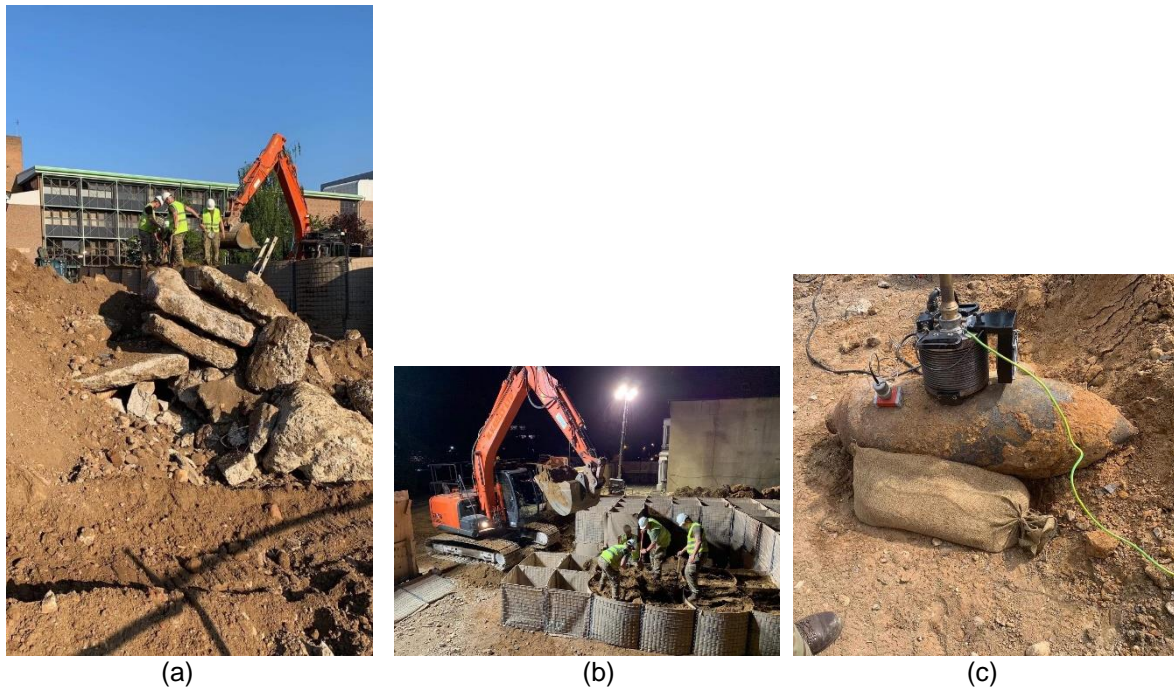
Figure 4 : Some photographs, courtesy of the Royal Engineers of Carver Barracks, showing aspects of the site prior to their controlled detonation of the bomb. From left to right : (a) Engineers filling sandbags around the bomb. Kingston University's Sopwith building can be seen in the background. The rubble in the front of the image is left over from the demolition of the buildings of the hotel located there until a few weeks before the photograph was taken, and is not directly related to the bomb explosion. (b) later in the same operation. Sand bags can be observed to be in place on three sides of the bomb at this point. (c) A close-up of the bomb and the detonator which the Engineers had attached to it. Part of a soldier's booted foot can be seen in the bottom left of this photograph, to provide a sense of scale.

For further work, we would aim to use graphical modelling using 3D Google Earth images to find the required height of the surrounding barrier made of sand bags so that no building in the vicinity falls within the line of sight from the explosion. We would recommend that in future such controlled detonations (i) precautions should be taken to increase the level to which the surrounding sand bags were raised, to avoid any building remaining in the direct line of sight from the point of detonation and (ii) there should not be any gaps left between the sand bags. This should avoid the possibility of the type of specular reflections of the sound energy discussed in our analysis.
