ACOUSTIC UPGRADE FOR THE CONCERT HALL OF THE SYDNEY OPERA HOUSE

G. Engel Müller-BBM Building Solutions, Planegg, Germany
J. Reinhold Müller-BBM Building Solutions, Planegg, Germany

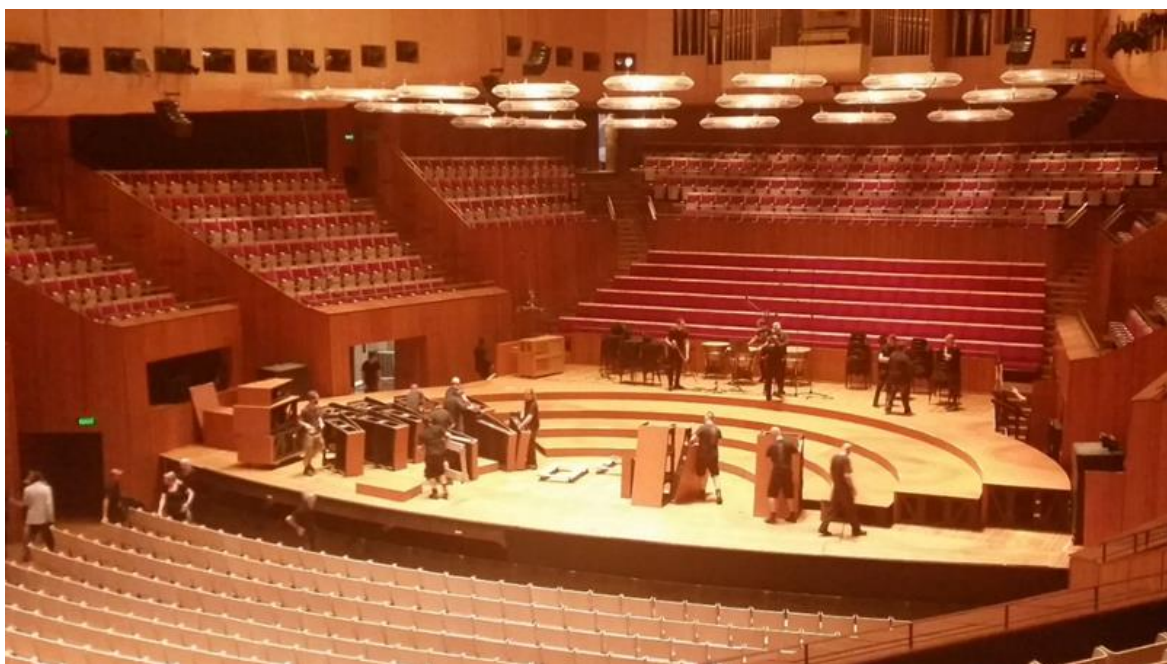
Figure 8. Riser testing 2016 – with the so-called donut reflectors above the podium.

To ensure the efficiency of the proposed measures and to collect input for further refinement, two blocks of in-situ testing were performed. During 10-day periods of rehearsals and performances of the Sydney Symphony Orchestra with added special rehearsals of the Sydney Philharmonic Choir and the Australian Chamber Orchestra, the new stage layout as well as the planned reflector layout were tested in the Concert Hall before being included in the construction program.
