Ghent, Belgium
Noise in the Built Environment
April 29-30 2010

Reduction of Vibration in a Station Building in South America

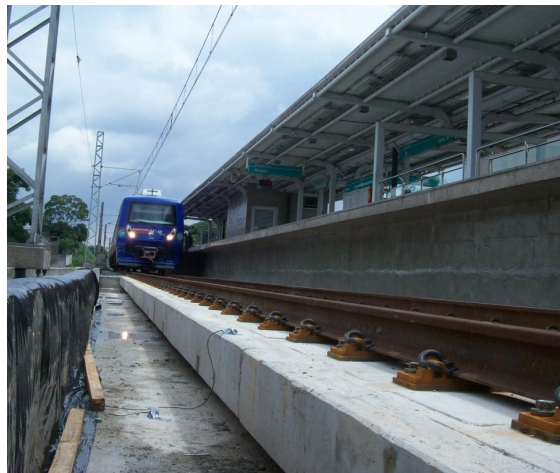
A CDM floating concrete slab on discrete elastomer bearings was installed under the running tracks (see Figure 2):

Figure 2: *CDM Floating Slab*

The chosen solution consists of a 44m long floating slab track with discrete supported rail. The floating track bed is composed of prefabricated concrete formwork panels (U-shaped troughs) in which a continuous slab is poured on site.

This floating slab is supported by discrete resilient pads, made of CDM-RR (resin-bonded rubber) material and have an equivalent static stiffness of about 4.5 MN/m^3 (for a slab width of 2,60 m) and an equivalent dynamic stiffness of 10.4 MN/m^3 . In longitudinal direction, there is a space of approximately 2,4m between the pads to allow air circulation and for the eventual installation of lifting jacks to inspect or replace the resilient pads.

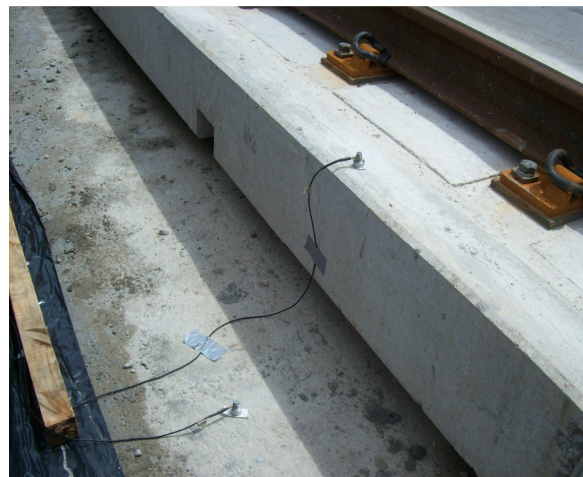
Figure 4: Vibration Accelerometers on and off the CDM Floating Slab (A4 and A5)

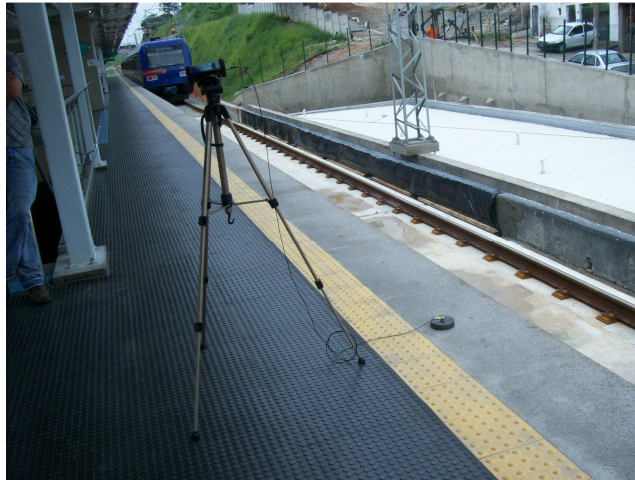
Figure 5: *Vibration Accelerometer on the Platform (A1)*

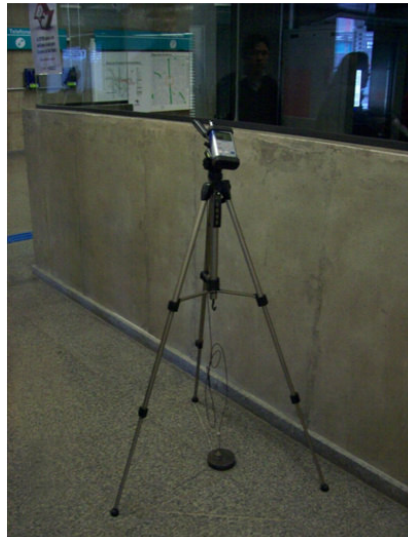
Figure 6: *Vibration Accelerometer on the Customer Enquiry Desk (A2)*

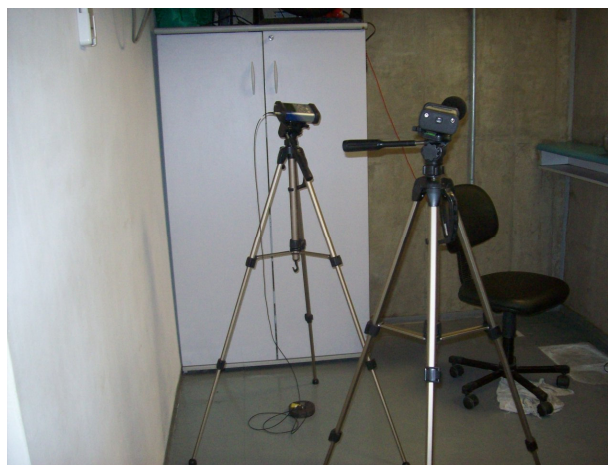
Figure 7: *Vibration Accelerometer in Ticket Office (A3)*
