ACOUSTIC RENOVATION OF A CIRCULAR-SHAPED SMALL MUSIC HALL

OC Ahn Youngsan University, Yangsan, South Korea
SE Jeon Pusan National University, Busan, South Korea
YH Kim Youngsan University, Yangsan, South Korea

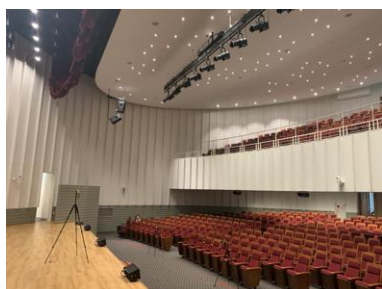
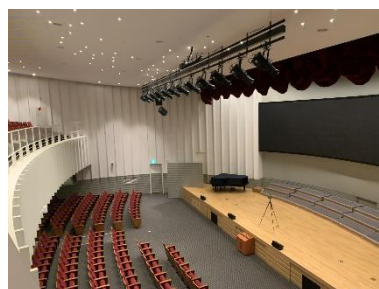
Figure 1. Interior views of the target hall

The target hall has a circular shape with an approximately 500 seats. The target hall has 364 seats on the first floor and 169 seats on the second floor. Figure 1 shows the interior of the target space before renovation. It is anticipated that the circular configuration may lead to a deficiency in the distribution of lateral reflected sound as shown in Figure 2(a), resulting in a lack of sound reaching the central portion of the seating area due to the phenomenon of sound focus on the center of the circular stage. In addition, as shown in the cross-section in Figure 2(b), the soffit space under the balcony was designed too deep ($D/H=3.5$) so that ceiling reflections barely reached it, and the viewing angle of the rear row was also impeded.

(a) Interior view from the stage

(b) Interior view from the balcony

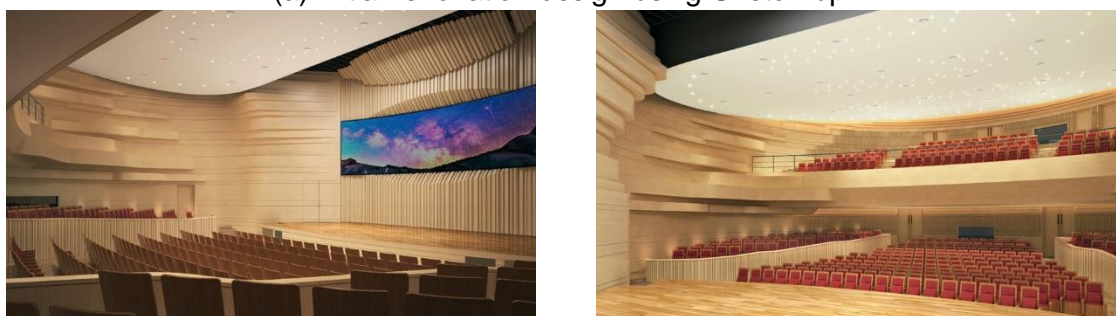
Figure 8. Pictures of the renovation design and construction

(a) Initial renovation design using Sketch-up

(b) Rendering view of the final renovation design

(c) Interior view of the target hall under the construction work

(d) Interior view of the target hall after the renovative construction work

Figure 5 shows the floor plan of the evaluated space, depicting the existing design and the proposed improvements. To enhance intimacy, visibility, and spatial impression, side balcony seating on the first floor and side balconies on the second floor have been added. Additionally, the interior of the walls has been modified to reinforce reflection, and the second-floor balcony has been reduced in size. Figures 6 and 7 present the simulation results conducted to predict the acoustic effects of the proposed improvements in terms of RT and LF , respectively. Figure 8 shows the pictures of the renovated design and construction progress.
