## NEW SOUNDS IN OLD BUILDINGS: REFURBISHING FOR THE PERFORMING ARTS

R Orlowski      Ramboll Acoustics, UK  
K Scherebnyj  
P Mudge  
T Jones

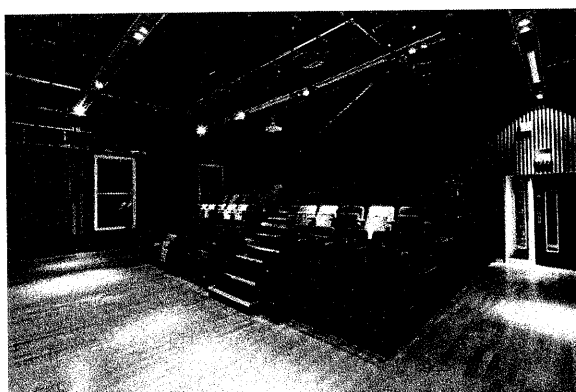
Figure 5 Views of Auditorium in Hornsey Road Baths

Room acoustic criteria were set for the various spaces based on their proposed uses. For example, the reverberation time criterion in the performance space on the upper ground floor was set at 0.8 – 1.2 seconds. The shape of the space namely, rectangular in plan with a pitched roof, lent itself well to providing good acoustics. To enhance sound diffusion, a wall lining of timber slats was added which was made absorbent on the rear wall. Drapes were added to provide some acoustic variability.
