AN OVERVIEW OF ON SITE TEST RESULTS OF CLASSROOM CORRIDOR WALLS, INCLUDING THE EFFECTS OF DOORS, GLAZING AND VENTILATORS, POST BB93

Ze Nunes MACH Acoustics, BEng(Hons) MIOA
 Andrew Rickard ISVR MEng Acoustical Engineering Student,
 Jeremie Dufaud MACH Acoustics, Msc

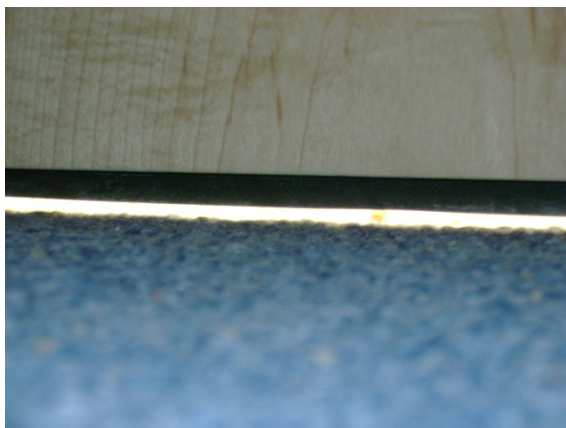
Pic 1. Drop seal falling short of the floor finish

A pair of wiper blades in combination within a threshold strip, provided the best results. This was followed by a single blade wiper seal, in combination with a threshold strip. Drop seals provided by far the worst performance. Drop seals have a tendency not to drop or only drop on one side; problems arise as a result of small objects getting stuck in the drop seal mechanisms; if the gap between the door and frame was too large, the drop pin remains partially compressed resulting in the seal not dropping; other faults occurred as a result of gaps, when the straight wiper seal dropped onto an uneven floor finish. It is estimated that 25 – 40% of doors to classrooms were compromised by a fault associated with this type seal, see Pics 1 and 2.

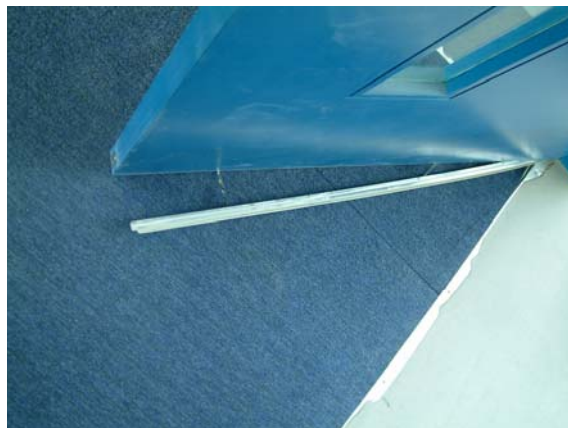
Pic2. Drop seal pulled out from under door

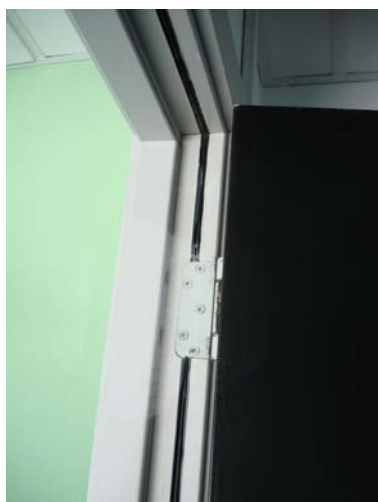
Pic 3. Hinges cutting through wiper seals – correct detail on the right

Perimeter Strips - Providing these seals where fitted correctly and made contact with the appropriate elements, they worked well, see Pics 3 to 6.

On the other hand, it was seen that 25-50% of the door locks, hinges, door closers and other elements, broke those seals, resulting in the acoustic performance of these seals being compromised.

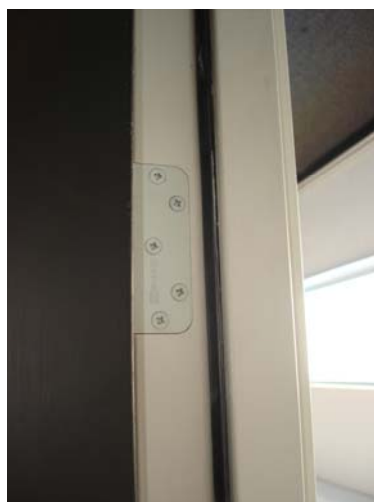
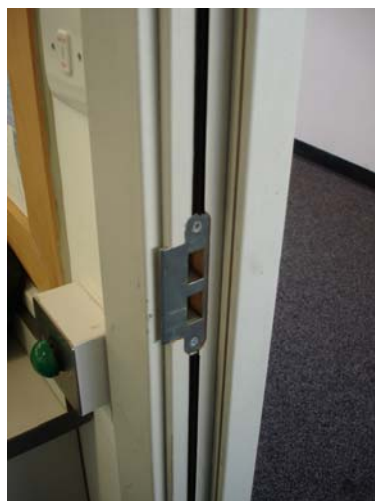
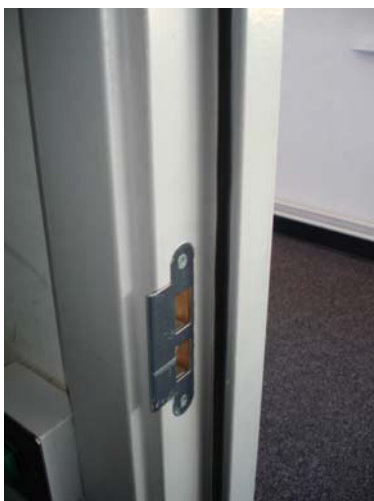
Pic 4. Door locks cutting through wiper seals – correct detail on the right

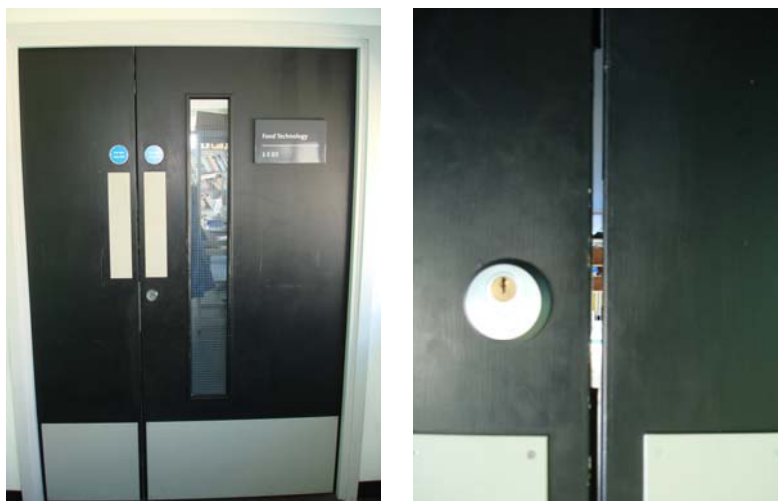
Pic 5. Large gap between double and leaf & a half doors – a very common fault

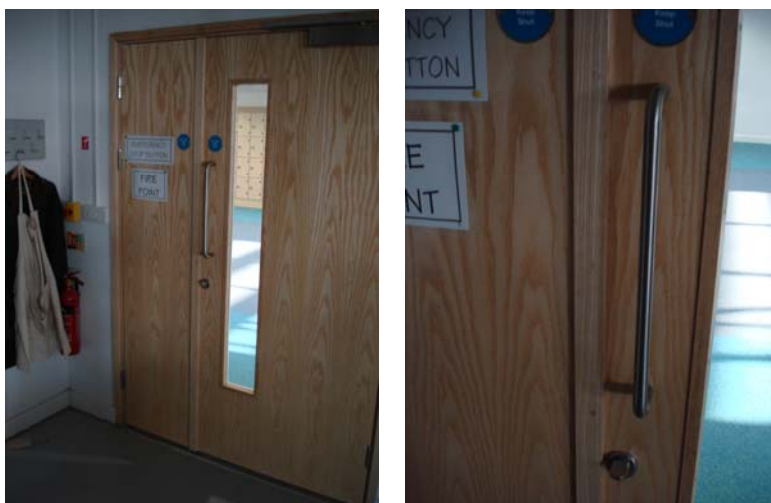
Pic 6. Double door containing cover plate between doors,
Such to ensure the performance of such doors

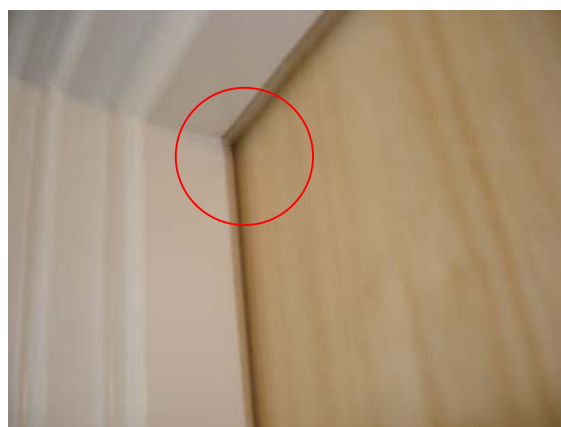
Head-Leading Edge of the Door - In many instances, the head-leading edge of the door, did not make contact with the door rebate, see Pic 7. In most cases, doors bent away from the door rebate. It is seen that 10 - 25% of doors were limited by this detail.

Pic 7. Gap – Door head-leading edge bending away from the door rebate,
A common fault

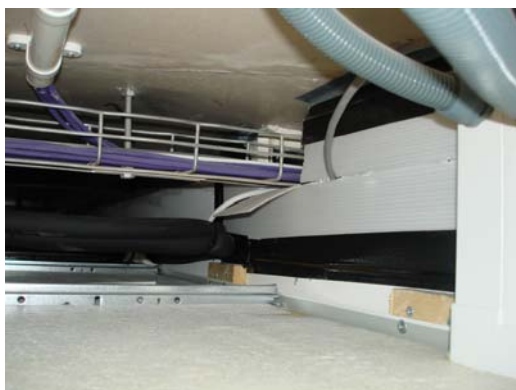
Site Observations - This school was the only school which was seen to be affected by poor build quality. Large gaps had been left above partitions hidden by ceiling tiles, such to allow the passage of services. In some instances, plasterboard had not been taken to the underside of the slab, See Pics 8 and 9. In many instances, the threshold seals to doors failed to drop or correctly seal with the floor finish. A variety of perimeter seals to doors were used throughout this development.

Pic 8. Poorly sealed service penetration

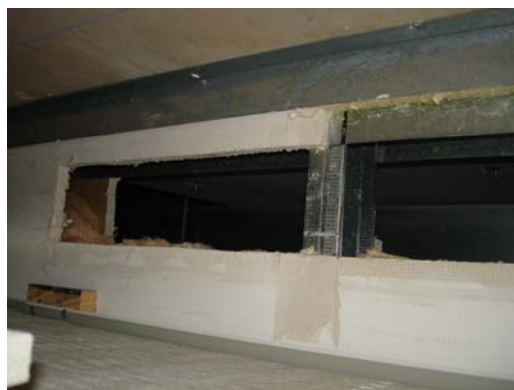
Pic 9. Plasterboard missing at the top of partitions

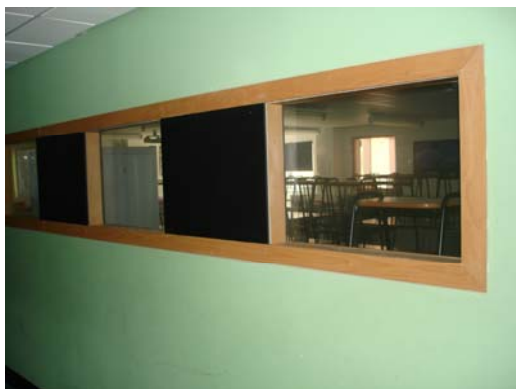
Pic 9. Poor detailing around a Vision Panel

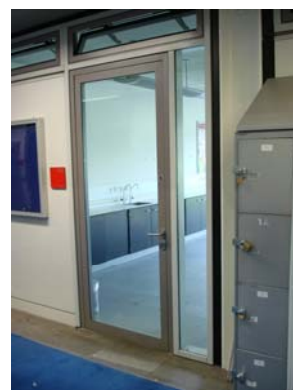
Doors are unlikely to have been rated to 30 dB, but were still of a very high quality. Doors were formed from aluminium frames in combination with heavy glazing, see Pic 12. The door threshold was not sealed, but all other edges were sealed with compression gaskets.

Pic. 12 Doors within School D

Aluminium Doors - Aluminium doors were used on one of the schools, School D. It is advised against using these doors since the leading edge of the door tended to be damaged/bent, preventing the doors from closing correctly.

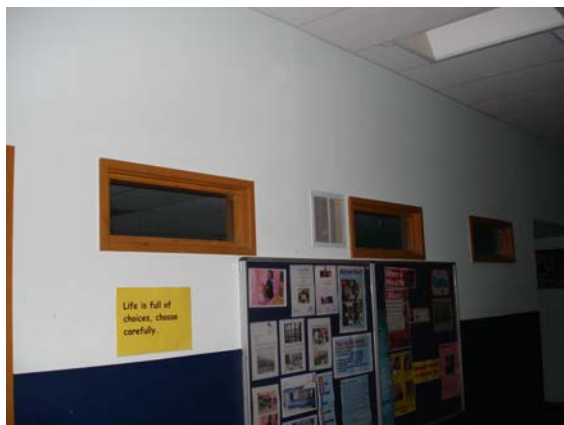
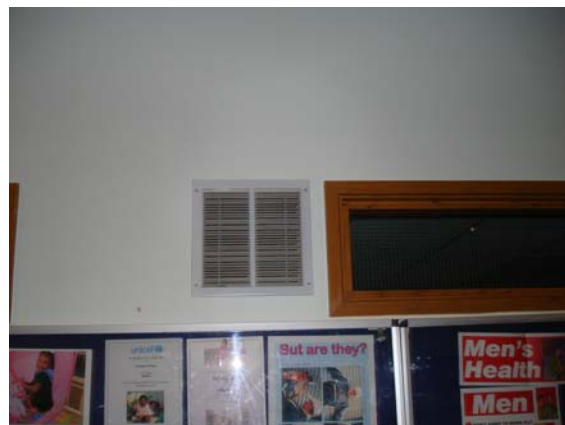
Site Observations – The unattenuated vent significantly compromised the performance of walls to corridors, although there had been no complaints from teachers.

Pic 13. Corridor walls including un-attenuated vent – School E

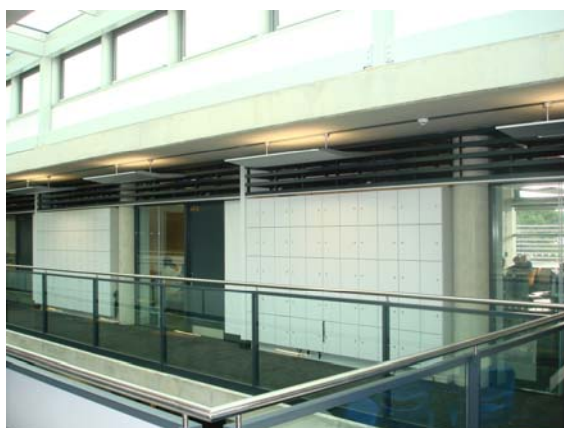
Site Observations – When vents were closed, the limiting factor was again the doors. When the vents were open, sound insulation was noticeably effected by the vents. Although, it was felt that attenuated vents still provided adequate levels of privacy, the acoustic performance of these partitions was still better than many cases where cross ventilation was not used.

Pic 14. Vents within Atrium of School F

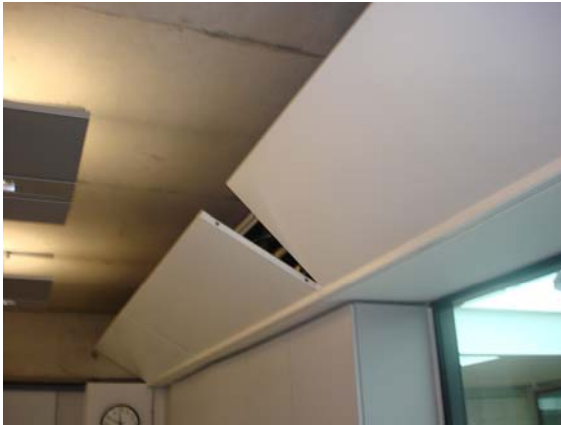
Pic 15. Vents within classrooms - School F

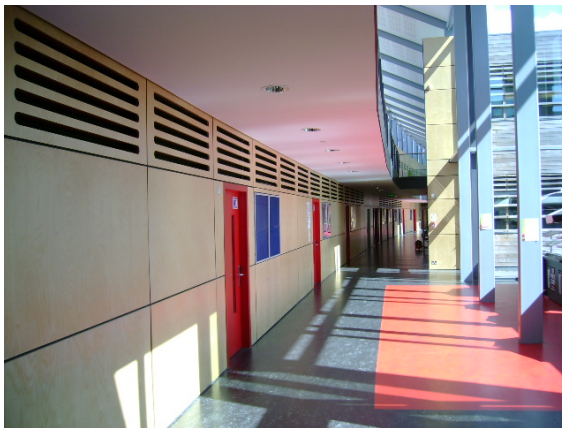
Pic 17. Vents within atrium of School G

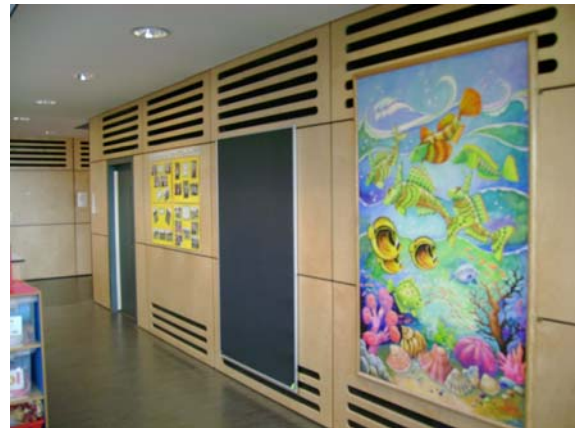
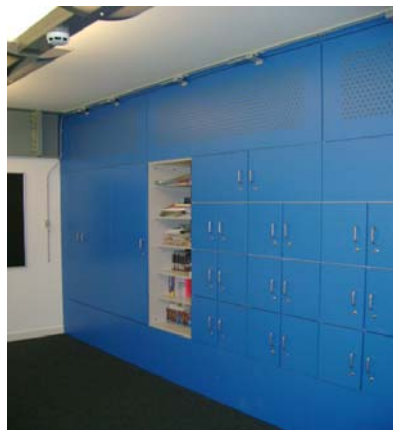
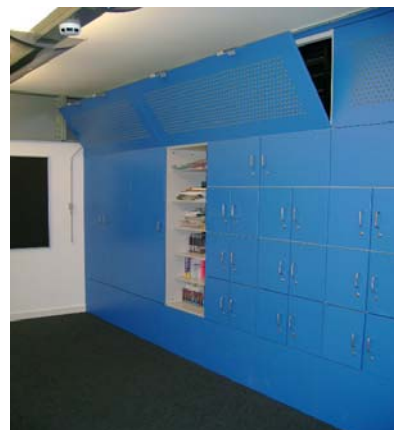
Site Observations – Same findings as School E. Interestingly within this school, vent operating handles in all classrooms had been removed by the schools management. This is taken to mean that the school was happy with the level of separation offered by the open ventilators.

Pic 18. Vents within classroom – Vent open within left hand side image – School G

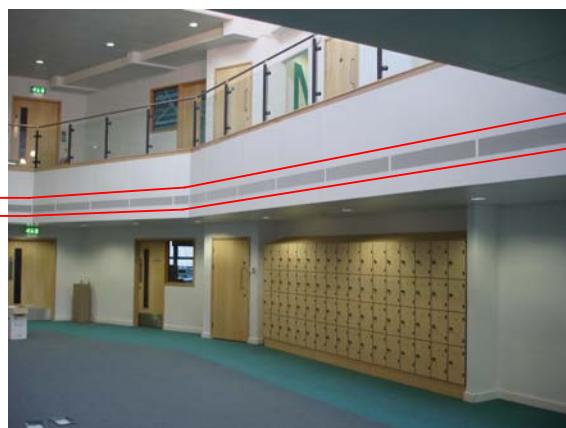
Site Observations – Corridor walls and ventilators provided an equal performance to that of a school employing single sided ventilation. As always, the sound insulation was limited by the door, principally at the threshold. No sound could be heard coming from the ventilators.

Pic 19. Attenuator ventilator within classroom Ground Floor – School H

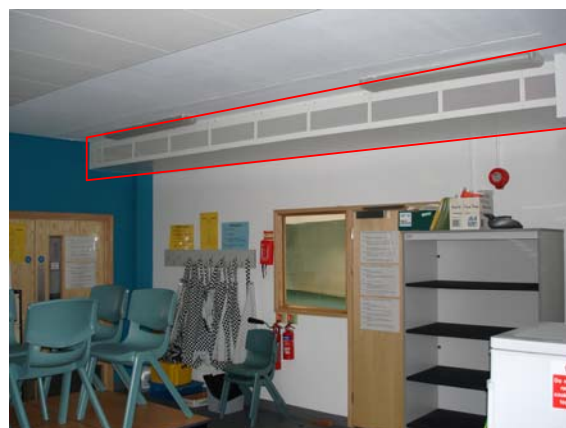
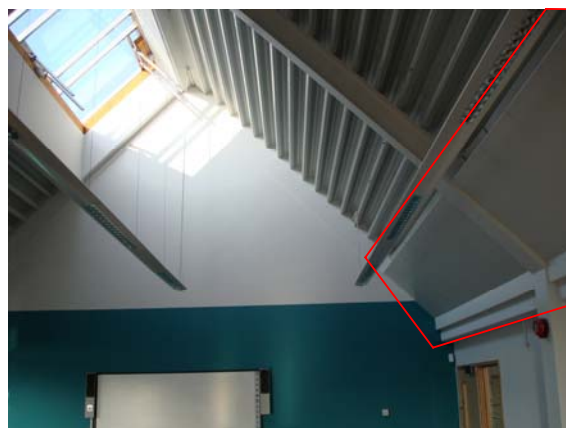
Pic 20. Attenuator ventilator within Classroom First Floor – School H
