ACOUSTIC DESIGN OF THE REFURBISHMENT OF THE HALLS, WOLVERHAMPTON

A Harper	Sandy Brown Ltd
J Wright	Sandy Brown Ltd
M Howarth	Sandy Brown Ltd

The Grade II listed Wolverhampton Civic Hall was built in 1938. It was closed in 2015 for a major refurbishment and reopened in 2023. The building contains two main performance spaces, the Civic Hall and the Wulfrun Hall, with new capacities of 3,400 and 1,200 respectively.

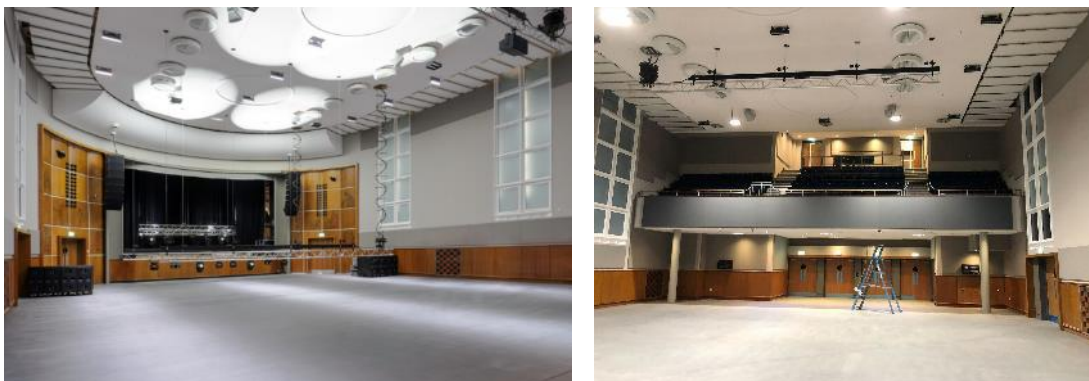
Figure 4 Wulfrun Hall acoustic finishes

Within the Wulfrun Hall sound absorbent wall panels were provided at high and low level to the side walls as well as to the rear balcony and rear wall, to control strong reflections from the stage.

Images showing the treatment are provided in Figure 4 and Figure 5.

- Monolithic central ceiling with an “acoustic plaster” system applied to a perforated board
- The same system installed to the underside of balconies
- Acoustic baffles around the perimeter of the ceiling to replace the previously castellated ceiling detail
- Sound absorbent wall panels to the front of balustrade and to the stage walls
- Fabric seating with perforated underside

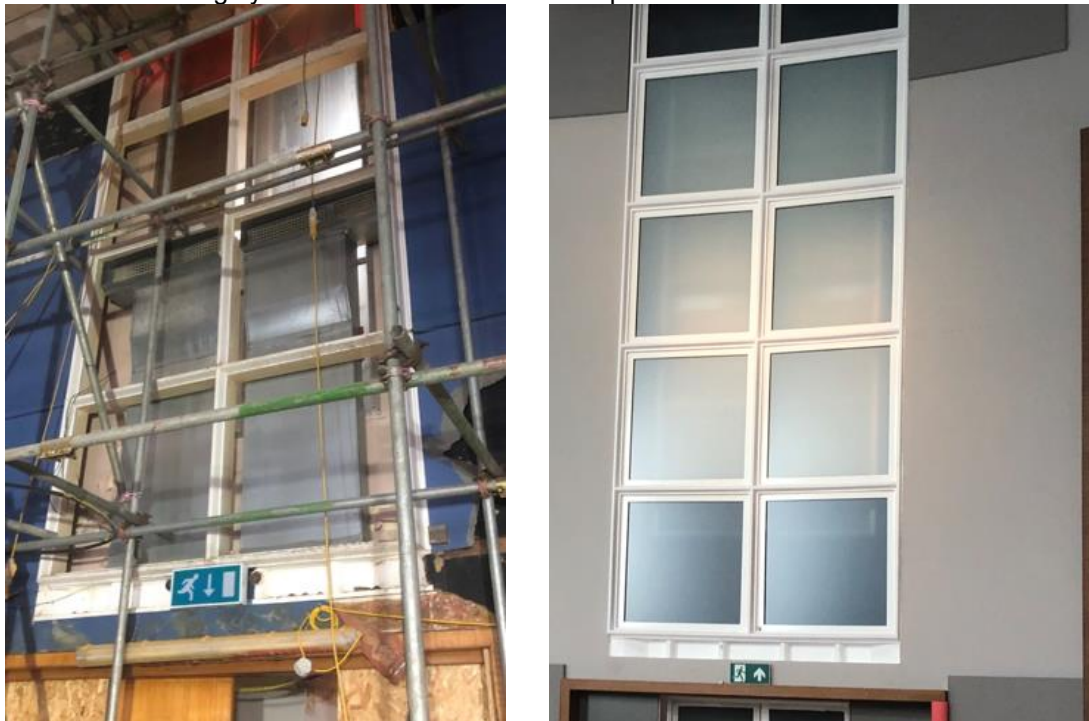
Figure 7 Glazed elements within separating walls (existing left, refurbished right)

The Lantern Bar shares both a separating wall (containing glazed elements) along with a separating floor with the Wulfrun Hall. The goal within the Wulfrun Hall was to retain the visual appearance of the space, which included the presence of the glazing. The existing glazed elements were retained and sealed, before having independent linings added within the Lantern Bar, to increase the level of acoustic separation as far as practicable.
