HAND-ARM VIBRATION FROM AN INDUSTRIAL SANDER AND ITS HEALTH EFFECTS

D M Bexon(1), R J Weston(1), & H J Woodroof(2)

- (1) RAF ICOM
- (2) Institute of Naval Medicine

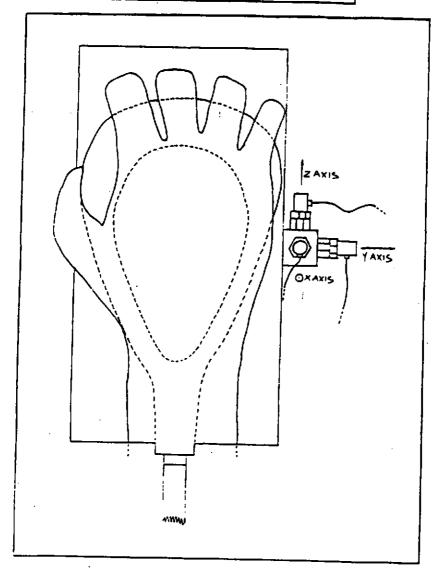
FIGURE 1

The B&K accelerometers were mounted on the SECO sander as shown in figure 1.

ACCELEROMETER MOUNTINGS ON SECO SS SANDER

Each accelerometer was screwed onto a B&K mechanical filter, in order to prevent the problem of d.c. shift in the signal. The filter and accelerometer assemblies were then screwed onto a small aluminium cube in the 3 orthogonal axes, which in turn was screwed to the side plate of the tool. All cables from the accelerometers were taped onto the body of the sander to prevent spurious vibrations occuring due to cable slap. Figure 2 shows a diagram of the whole measurement chain from accelerometer to portable computer.

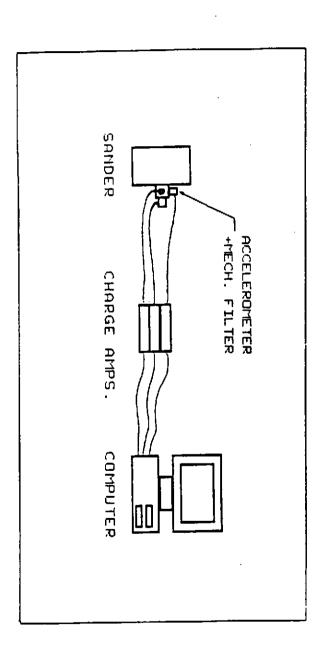
FIGURE 2

MEASUREMENT SYSTEM

Vibration levels were monitored using 3 B&K 4371 accelerometers, mounted in the 3 orthogonal axes. The output of these was then conditioned by B&K 2634 charge amplifiers and recorded by a digital acquisition system based on a GRID 1535 EXP portable pc. The digitisation rate was 5041 samples per second. The signal was low-pass filtered by 8 pole anti-aliasing filters, with a cut-off frequency of 1250 Hz. Subsequent analysis was carried out using a vibration analysis package called HVLab version 3.5.

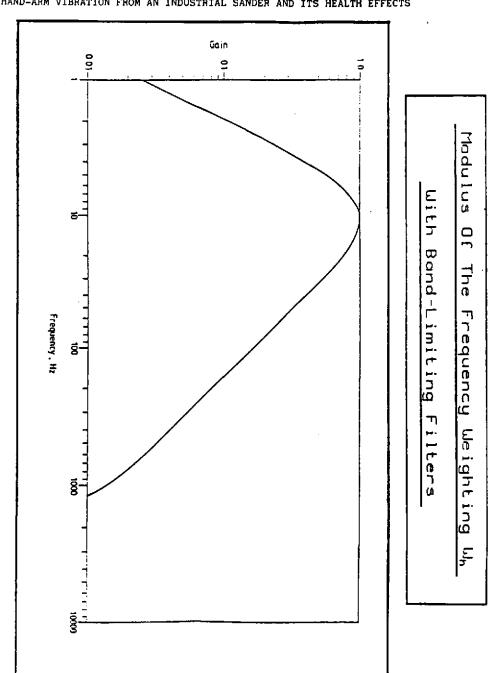
FIGURE

In order to calculate the frequency weighted r.m.s. acceleration produced by the sander, various operations were performed on the raw data files acquired. This chain of analysis is shown schematically in figure 3. The signal was frequency weighted in accordance with BS 6842, the filter shape used being shown in figure 4. To calculate the predominant frequency of vibration of the sander, the signal was normalised, then the power spectral density was obtained.

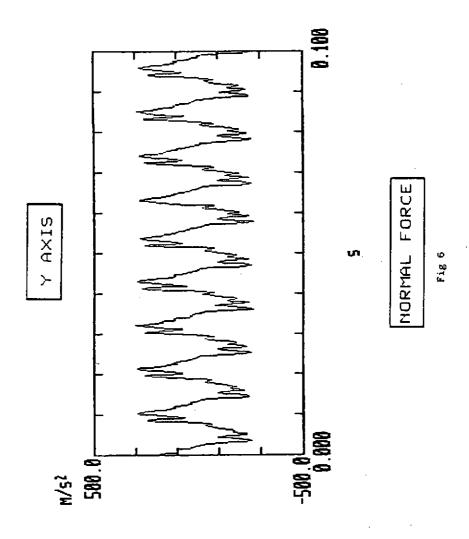
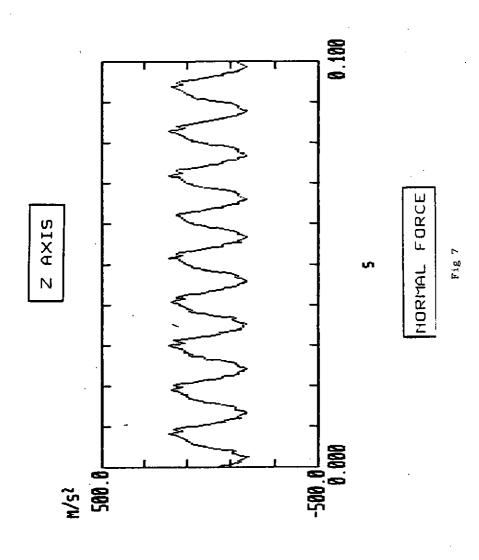
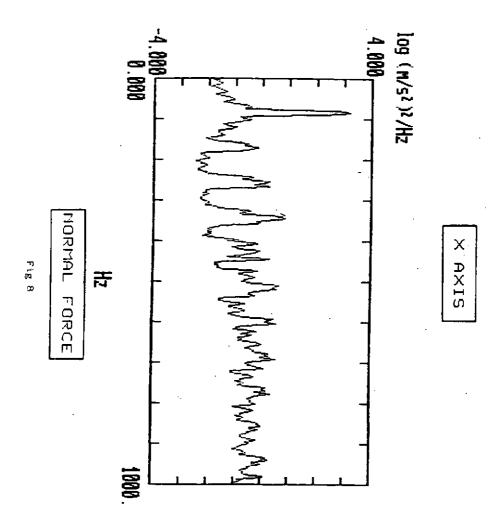
Figures 5-7 and figures 8-10 show the time history plots and power spectral density plots respectively for each measurement axis, for normal sanding. Table 1 shows the frequency weighted r.m.s. acceleration tabulated against each sanding technique measured, for the 3 measurement axes.
