# COMBINED IMAGING TECHNOLOGIES FOR DETECTION OF AIR LEAKS IN MODERN AIRTIGHT CONSTRUCTIONS

The aim of this study is to develop a combined imaging system for the diagnosis of air leaks and diagnosing thermal and sound transfer through leaks and ventilation in modern homes. This paper will present the results of a collaborative, interdisciplinary project exploiting two unique world-class sets of expertise and experimental facilities from the University of Salford: the Acoustics Test Laboratories and the Energy House. Conventional air-tightness testing procedures for homes are proposed by building regulations for the detection of air leakage paths. By introducing sealing measures, the heat loss and noise break-in inside homes through such air leaks can be reduced. These tests are usually time consuming and do not provide any information on the heat and sound transfer through the leaks. The technology proposed here is a combined measurement and analysis solution utilising the Microflow PU acoustic sensor and the FLIR thermal imaging camera. The FLIR thermal camera is used for localising weak thermal insulation areas. However from the thermal image, it is not always clear if the weak

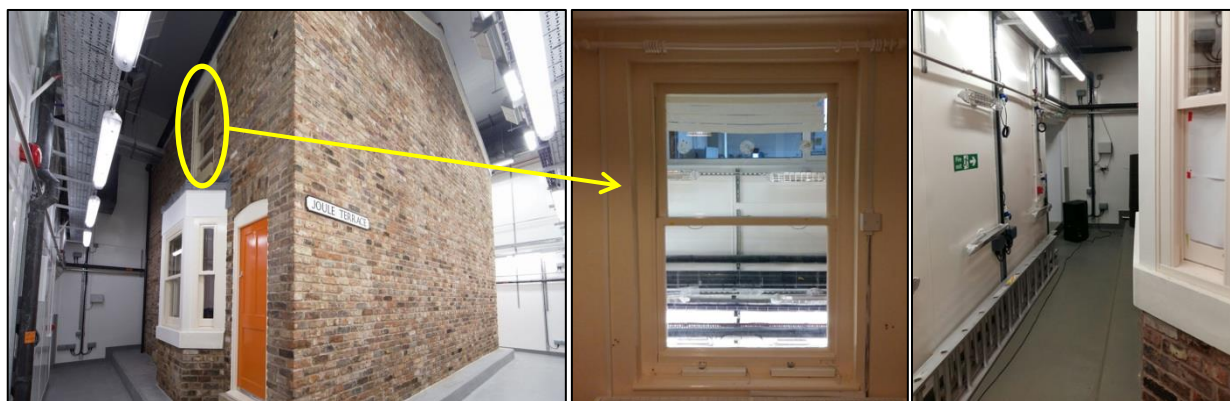
**Figure 1: the energy house (left), the window tested (centre) and the loudspeaker in the house compound (right)**

The tests were carried out in the Energy house at University of Salford. The Energy House at University of Salford (Fig. 1) is a full scale house built inside an environmental chamber. The environmental chamber is controlled and different environmental conditions can be simulated, for ex., rain, wind and sub-zero temperatures. The building in the chamber can then be tested with different materials under a controlled environment.

To diagnose the sound transmission through the window, the Energy house compound was excited by a loudspeaker driven by pink noise excitation. A sound field is set up around the energy house and this causes the sound to be transmitted to the bedroom from paths such as the window and any leaks/openings in the window. Using the P-U probe, a scan was conducted over the window to measure the pressure and acoustic particle velocity normal to the window inside the room. Using Scan and Paint technology, these scanned quantities were mapped on the window. At first, the window was scanned fully closed (to detect leaks) and then with 3 window openings (5, 15 and 24 cm) with and without curtain to measure the sound transfer. The window chosen for the study is shown with the loudspeaker outside the house in Figure 1.

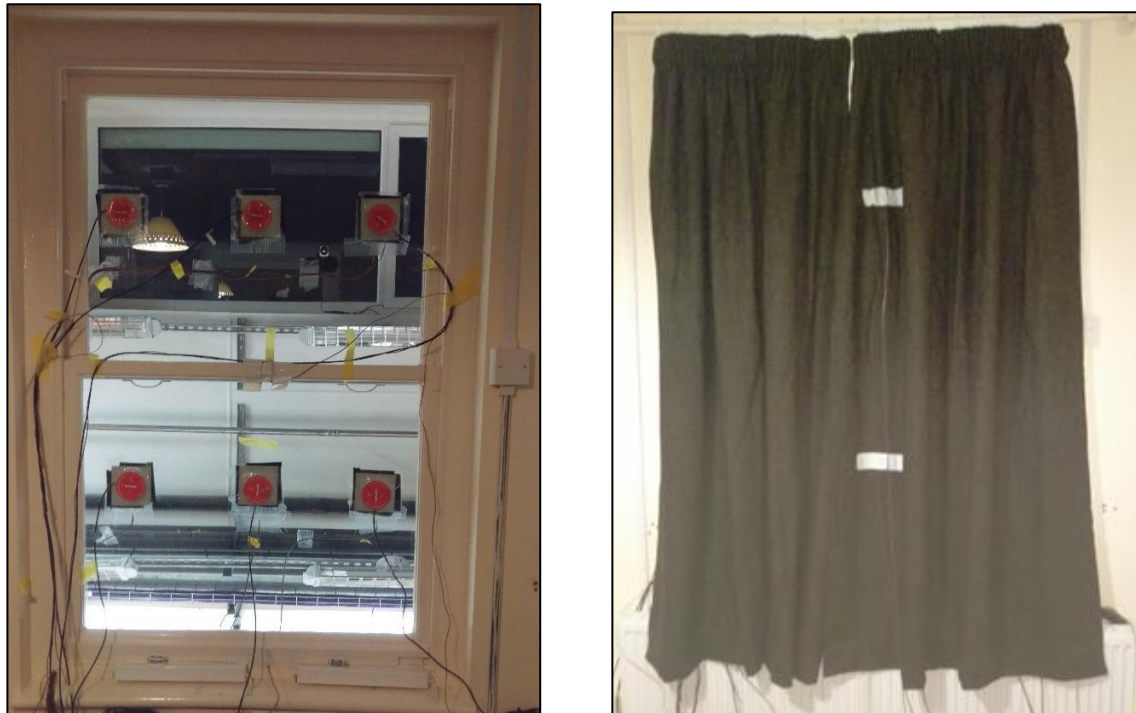
Figure 2: U-value measurement setup showing position of heat flux sensors (left) and with tweed curtain (right)

An array of Hukseflux HFP01 heat flux plates are fixed to the internal surface of the glass. On both internal and external surfaces are thermocouples which record the temperature; data is collected at intervals of 1 minute. The method for calculating U-value, as used by Wood et. al. [10], combines heat flux, surface temperatures and surface thermal resistances, as set out for the average method in [9]. Each experiment observes the U-value across a test period during which heat is applied to the room. A heater is situated to the rear of the room so as to allow heat to circulate around the room. This is done to initiate steady state conditions within the room and thus through the tested element. A set point of 22°C is used for the room, while the external temperature is regulated to approximately 5°C using a dedicated HVAC system. This temperature difference of above 10K was used to promote mono-directional heat flow through the element.

Table 1 show the U-values of the window glazing with and without the curtains. The test setup can be seen in Figure 2. Again a clear reduction in U-values can be seen when the curtain is used demonstrating its effectiveness in reducing the thermal transfer in the room.
