A DETAILED, TRI-AXIAL MEASUREMENT OF THE PERFORMANCE OF A BASE ISOLATED BUILDING IN LONDON DESIGNED TO PREVENT STRUCTURE BORNE NOISE AND VIBRATION FROM UNDERGROUND TRAINS

This paper reports on a detailed study on the performance of a vibration base isolation system for an 8 storey steel frame education building in London which was built in close proximity to a shallow part of the London Underground Central Line. The study was a collaborative exercise between Bickerdike Allen Partners (BAP), who created the initial base isolation system specification, Farrat who designed, manufactured and supplied the vibration isolation system and SRL Technical Services Ltd.

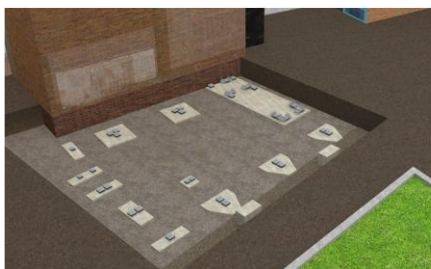
Figure 2

Figure 2: Bearings and shear keys installed on pile caps

The full building – base vibration isolation system comprised Farrat high performance natural rubber elastomeric bearings designed to match the loadings at each column and core point in the building (figure 2). The bearings were placed, levelled and grouted into place on each pile cap (Figure 3) and then reinforced concrete (RC) ground beams were cast on top of the bearings creating a matrix grid (Figure 4) which supported 250mm thick pre-cast-planks covered by a 50mm thick RC topping.

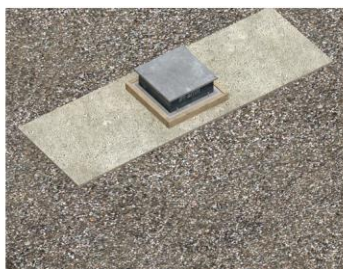
Figure 3

Figure 3: Bearing installation with basic shuttering to pour supporting non-shrink grout bed

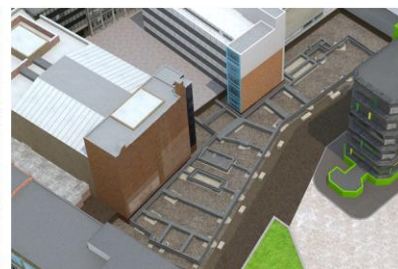
Figure 4

Figure 4: Ground beam grid matrix constructed on top of bearings

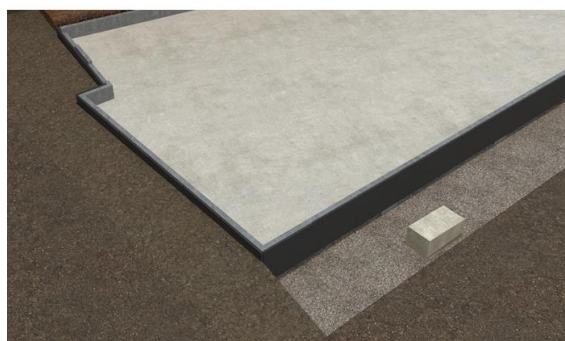
Figure 5

Figure 5: Isofoam isolation between subterranean structure and back-filled landscaping

Isofoam perimeter isolation material was used around the majority of the subterranean outer perimeter of the building where ground beams were cast directly up against existing buildings or where the ground was backfilled up against the threshold (Figure 5).

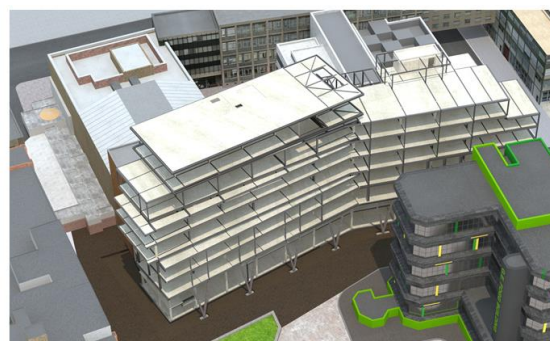
Figure 6

Figure 6: Standard steel frame construction onto isolated ground floor

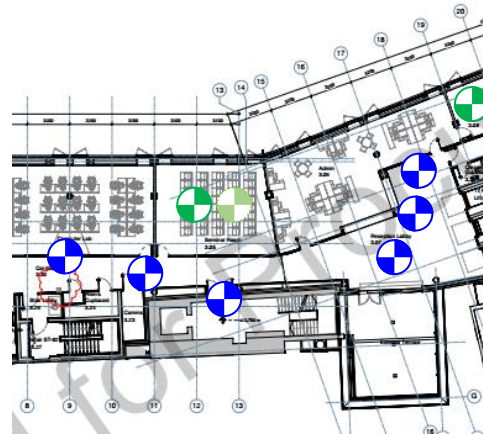
on 2nd floor
Figure 3: Post-completion survey –measurement positions. NB: vibration measurements are shown in blue, noise measurements are shown in green

Just prior to completion, noise and tri-axial vibration was measured in the fully isolated building. Triaxial¹ vibration measurements were taken simultaneously at various locations on the Ground Floor and on Level 3, see figures below. Positions on the ground floor included un-isolated and isolated elements. On Level 3, locations included a mid-span and close to structural columns. Measurements were also taken in the un-isolated staircase linking the Graduate Centre with Engineering Building. Additionally, spot noise measurements were carried out at three positions on Levels 2 and 3.

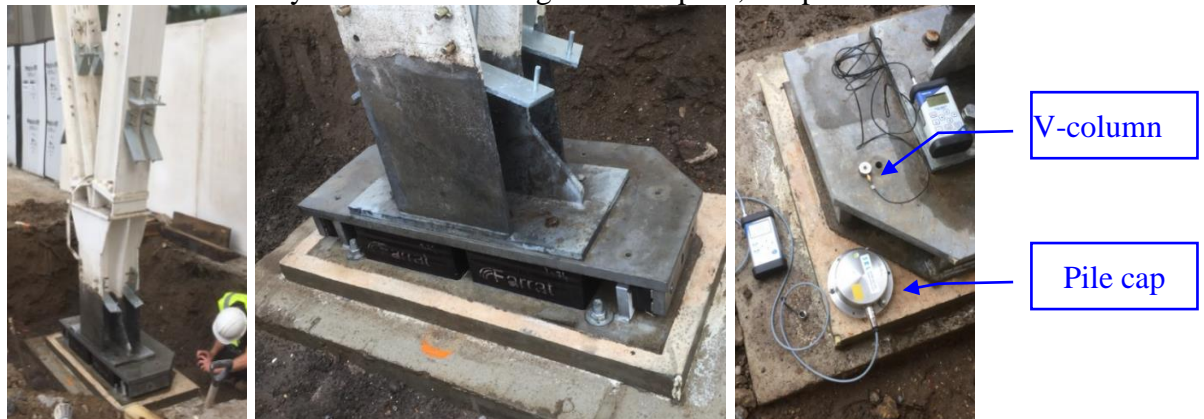
Figure 4: Locations of External Measurements

Externally, measurements were taken on the un-isolated pile cap at the foot of a “V-column” located outside the footprint of the ground floor of the building. Measurements were also taken on the steel column foot located directly above the building isolation pads, see photos:

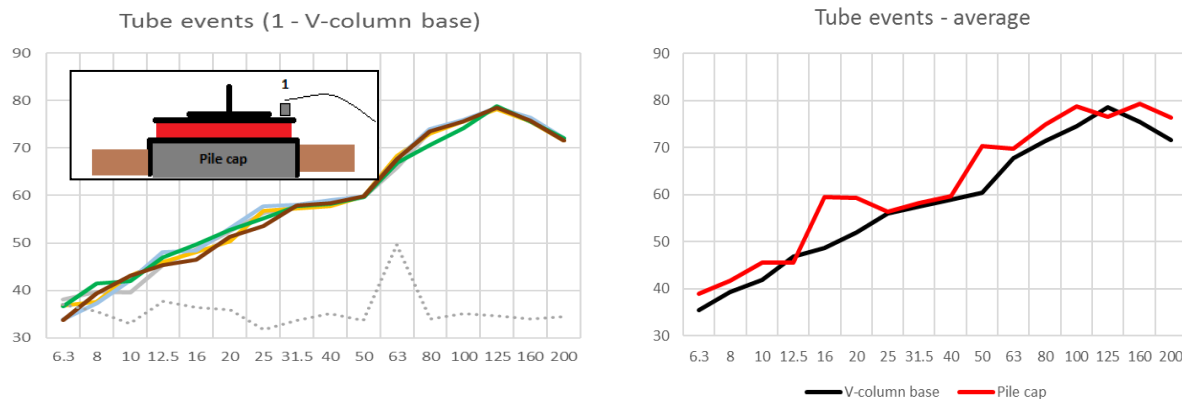
Figure 6: V-column vibration: Left chart - individual events; Right chart - average vs pile cap

Vibration levels measured on the foot of the V-column also provided consistent data, see figure below.

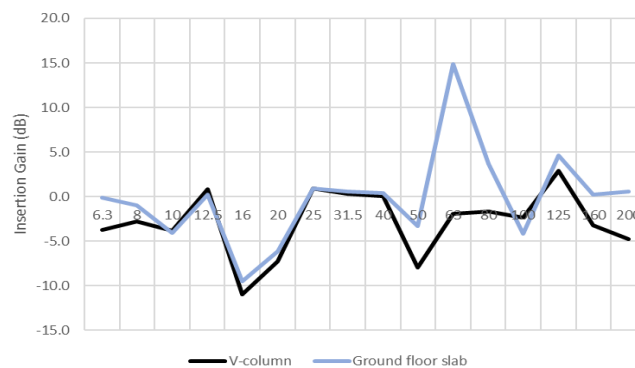
Figure 9: Transfer functions from the pile cap to different points at the base of the building

Comparison of the Transfer Functions from the pile cap to both the V-column base and to the ground floor slab (see Figure 13) shows very consistent results other than at the 63Hz octave, which is thought to be affected by the floor resonance. This is a strong indication that the vibration across the base of the building appears to be a function primarily of the energy entering the building (via the pile caps and pads) and the effect of the superstructure of the building as a whole:

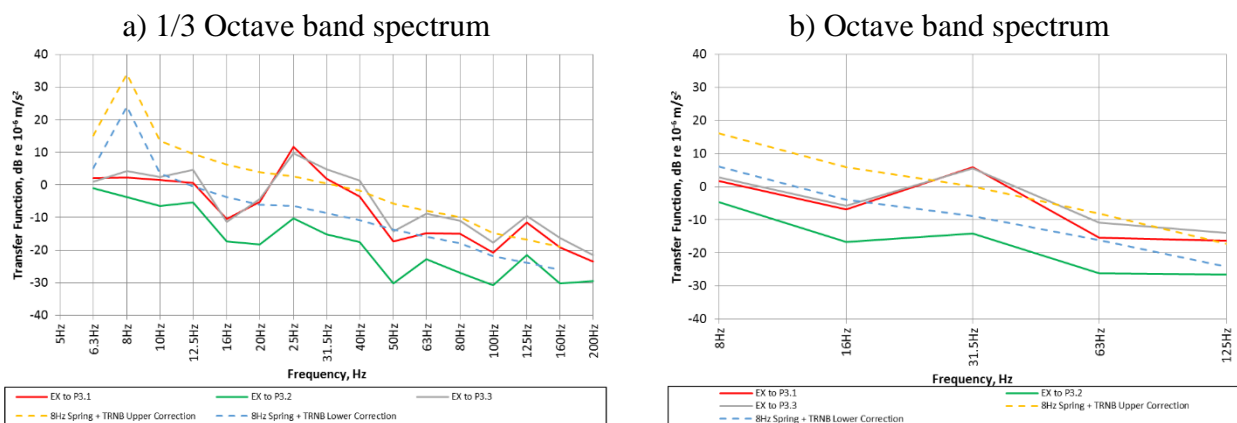
Figure 11: Transfer functions: external to third floor – field vs theory

Figure 11 compares transfer functions between un-isolated pile cap and isolated third floor vibration levels, and theoretical transfer function based on the high and low amplification values reported in [2] and the theoretical response of a 8Hz rubber pad in a single DoF system. In general, the measured performance follows theoretical curves decreasing at a rate of approximately 7 dB per octave. This is shown especially well on the octave band spectrum graph in Figure 11.

As observed earlier, there is no expected amplification at the resonance frequency of the pads with the values around 0 dB instead. At lower frequencies, the measured transfer function follows Lower Curve. At 25 Hz, the levels are amplified by around 10dB after which transfer function follows Upper Curve more closely. Transfer function measured at a position near a column is generally well below the Lower Curve.

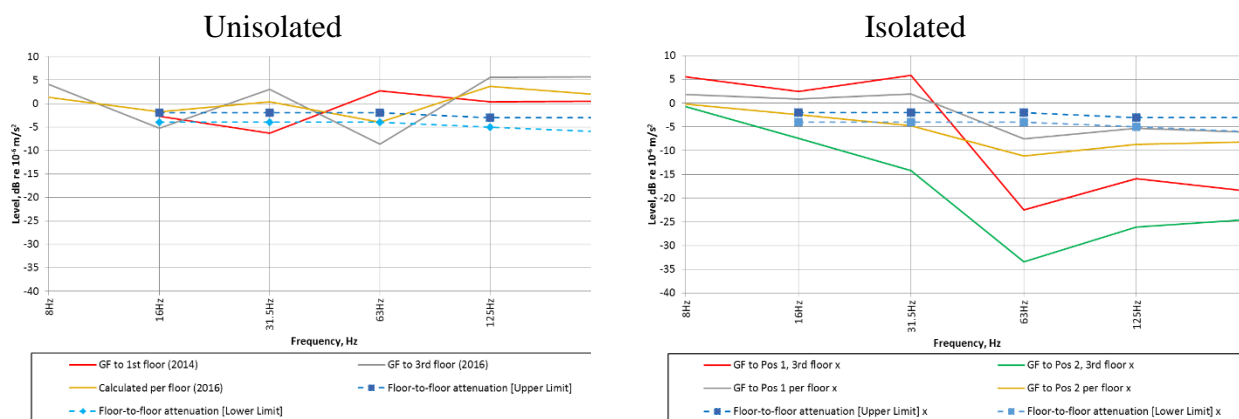
Figure 12: Attenuation per floor: field vs reference

Vibration levels generally reduce with height of the building. There is guidance available in literature on a typical rate of attenuation (e.g. [2]). Results of the 2014 and 2016 surveys allow comparison of field test data with the reference data, see Figure 12.

Difference in vibration levels on ground floor and third floor was divided by three to estimate attenuation per floor, as shown in [2]. For the QMU building, survey results in the un-isolated part corresponds well with the reference curve in the low frequency range but shows opposite effect in the higher frequency range indicating amplification. For the isolated data, however, the results generally follow theoretical figures with attenuation ranging from +2 (up to 31.5 Hz) to -11 dB attenuation across the frequency range. In overall, the theoretical figures would be on a conservative side.
