AN EXPERIMENTAL INVESTIGATION INTO THE NOISE OF A CONTINUOUS POSITIVE AIRWAY PRESSURE DEVICE

The noise source and sound pressure level of a functional continuous positive airway pressure device has been investigated in this paper. This paper outlines the experimental study conducted on this device to determine the noise source and identify the root cause of the noise generation in the continuous positive airway pressure device and hence reduce the noise generated. At the end of this paper the conclusions suggest that the major noise source was Structure Borne and the noise was caused due to rotational imbalance of the rotor inside the blower of the device which was deduced from valid experimental results showing that the first harmonic vibration was dominant. In addition to detecting the noise source, solutions to reduce the noise level have been suggested. Most effective method to isolate vibration was found to be addition of an isolation mount. Research was conducted on isolation mounts which included material of mount, mechanism of isolation, active and passive isolation approaches to reduce the noise and vibration generated from rotational imbalance.

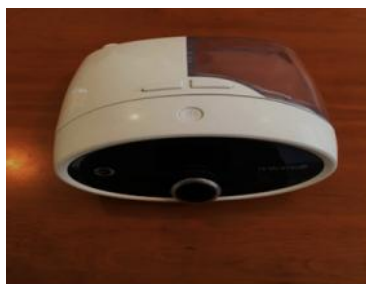
Figure 1: CPAP device

Experimental analysis of the noise generated from the CPAP device was the key objective of this research. For testing purpose, a prototype CPAP device was provided, as shown in Figure 1. This experiment was conducted in RMIT University and the major analysis was done using ‘B & K Pulse Lab shop’ software, which was used for:

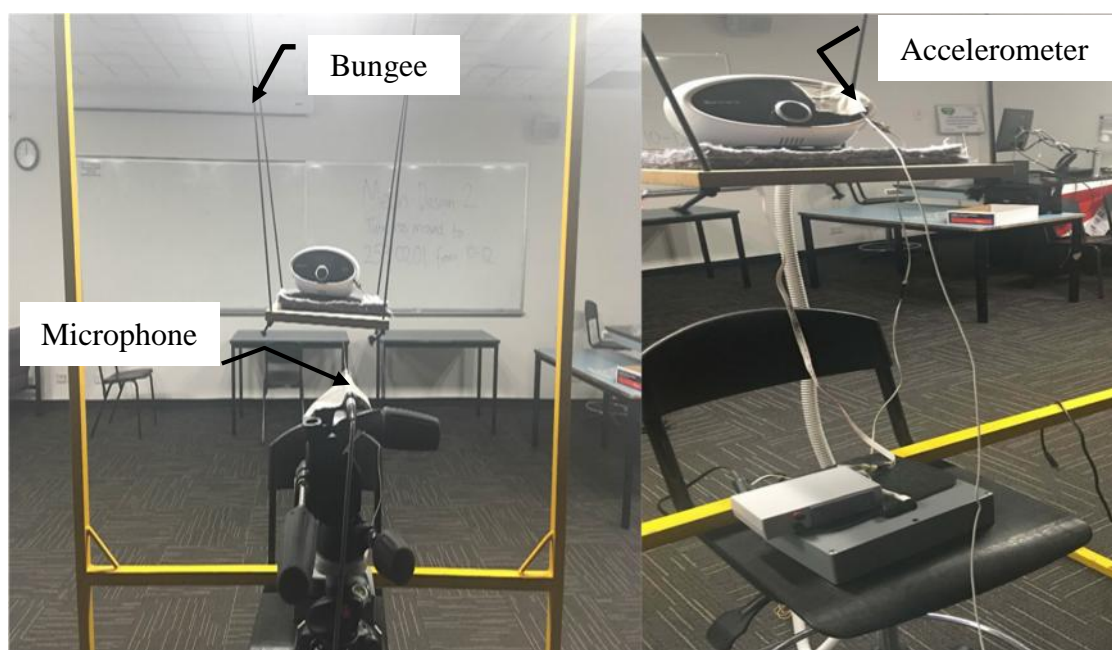
Figure 2: Experiment set up for CPAP device

In order to assess the noise, figure 2 and figure 3 show the experiment set up and the experimental procedure and test conditions were followed:

5. Major data acquisition transducers used were a microphone and an accelerometer
6. Microphone was calibrated and placed 1m away in the same height as the test device and parallel to the test device to ensure the standard ISO test conditions.

7. Accelerometer was installed on top of the CPAP device (just above the blower location).
8. The hose which is connected to the patient's gasmask was inserted into an acoustic quiet box to eliminate the air borne noise due to air flow fluctuation. This acoustic quiet box was placed at the bottom end of the stand.

9. A stand frame and Bungee cords were used to suspend the test device and to isolate vibration from the surroundings

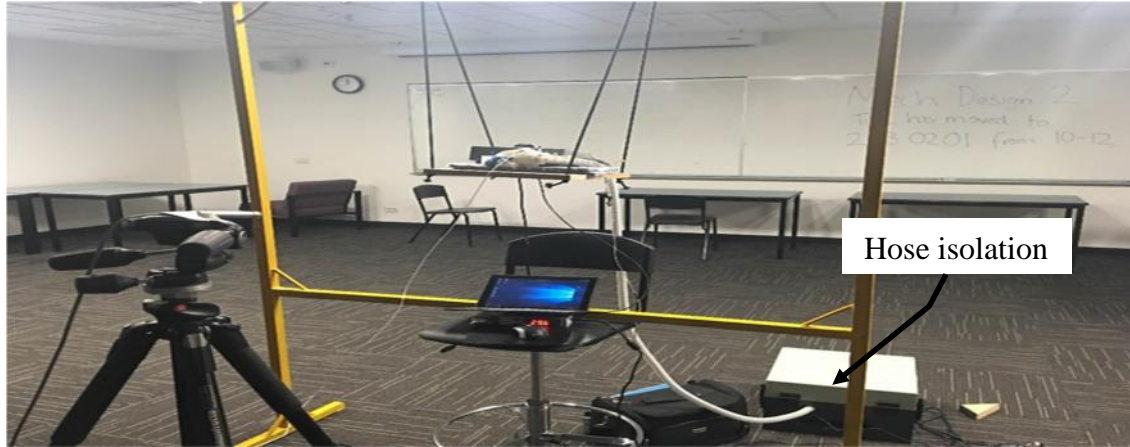
Figure 3: CPAP device without cover

2. Test was done on two different device assembly set-ups which were (i) the entire CPAP device (ii) the CPAP device without the humidifier cover located at the rear of the device.

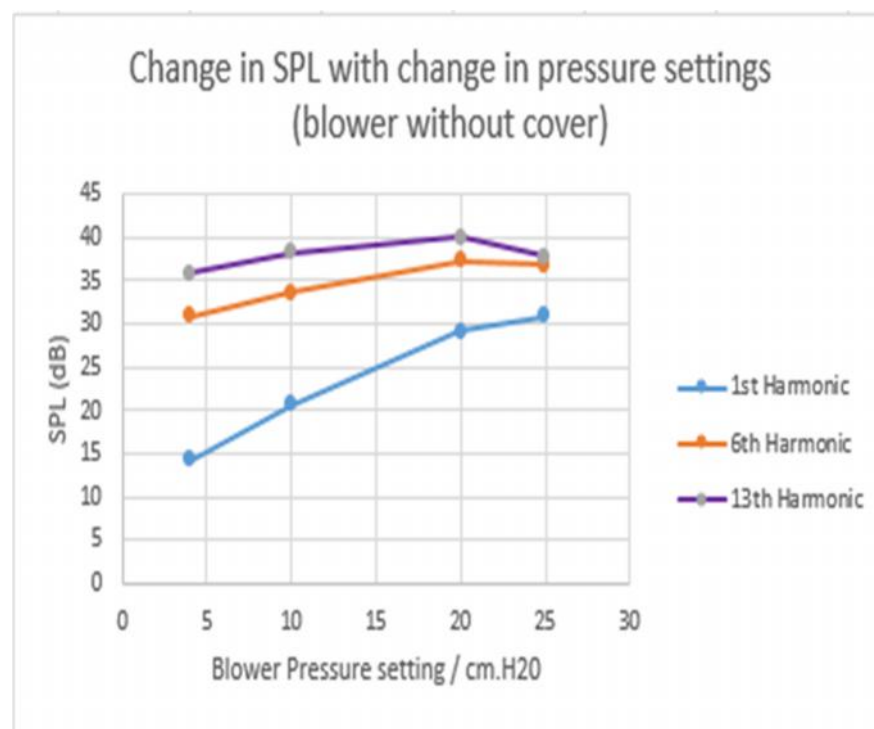
Figure 5: The SPL values versus the blower pressure settings at different harmonics without the cover

Figure 5 indicates that the 1st harmonic has the most effect on the SPL as the SPL changes for the 1st is much greater than that of the 6th and 13th harmonic.
