## REMEDIAL MEASURES FOR TIMBER JOIST FLOORS

S J Flynn, B R E Advisory Service, Building Research Establishment.

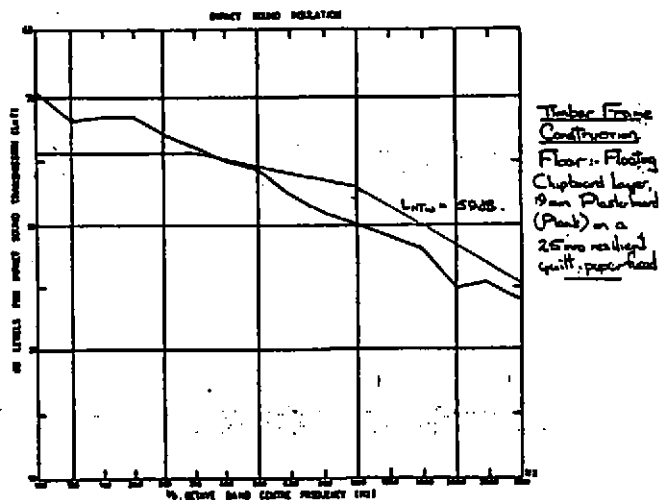
fig. 1.

The following slides illustrate my first example. A modern terraced timber frame house. The house construction was brick clad and the separating floors were a timber and plasterboard raft and battens on a floating layer of paper faced mineral fibre 25 mm thick. The measurements were made between two similar flats, on the lounge floor, with the upper flat unfurnished. The first slide (fig.1) shows an unmodified floor of an unfurnished lounge giving an impact index of  $L_{nrv} = 59$ . The next slide (fig.2) shows a measurement on the same lounge floor which was modified using a single hardboard layer, felt and a laminate isolating material giving  $L_{nrv} = 62$ . Comparing them, we see that the improvement above 250 Hz was quite dramatic, but at low frequency the performance was worse. The next slide (fig.3) shows the airborne measurement  $D_{nrv} = 55$  for the the original floor and then the next (fig.4) shows  $D_{nrv} = 52$  for the modified one. If we compare them, we see that there is some improvement between 315 and 630 but at both lower and higher frequencies the modified floor performed less well.

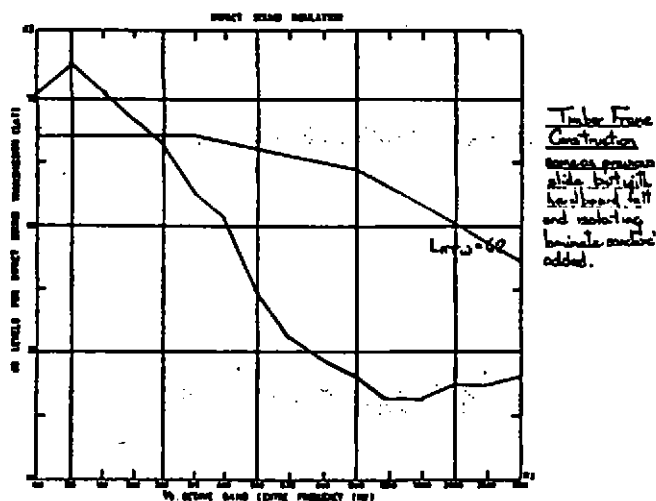
fig. 2.

The original complaint was about a child running and jumping on the separating floor, and this complaint continued after modifications. The lower floor occupants were an older couple who were reasonably active but found the constant activity above too annoying. There were several houses of this type where complaints were received about noise, particularly about impact noise and noise from vacuum cleaners and washing machines for dishes and clothes. The next two slides show again that the measured index value should have proved satisfactory, this being a measurement on a similar floor, to the previous slides, but when comparing its performance it is worse than the original floor conditions for the previous example.

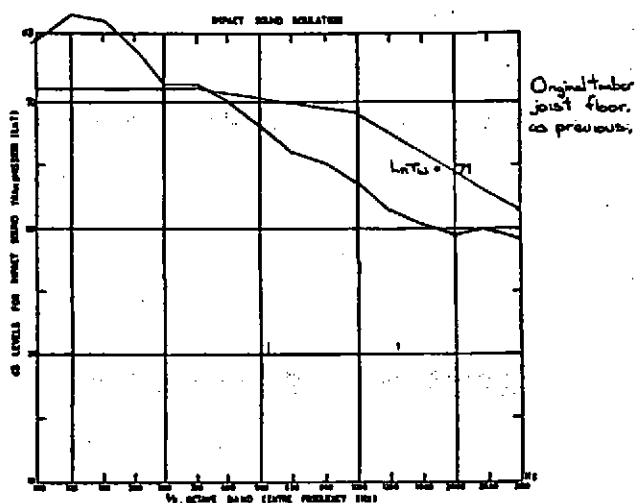
Fig. 7.

The next slides show the before and after for a 'Duplex' type flat, which is a 'house' type construction, either terraced or semi detached, which, post World War II was adapted to form two flats, sometimes with side entrances and outside stairs and sometimes with a front door to upstairs and side entrance downstairs. The first measurements were made on the original floor, which was similar to any internal wood joist floor construction of the time. This showed (fig.5), as expected, that the performance index was very low. An independent ceiling construction was added, with minimum joist depth 125 mm and only just clear of the existing ceiling, the absorbent quilt was placed between the new ceiling joists. It can be seen (fig.6) that the improvement in airborne sound insulation was good, but lower than hoped for because of various flanking paths. The impact performance was however much enhanced (fig.7&8) and with a  $L_{nT\omega} = 58$  gave a very worthwhile improvement. Both performance curves showed the best improvements at frequencies below 250 Hz.
