Proceedings of the Institute of Acoustics

VIBRATION ISOLATION OF TRAINS IN A FRENCH ARTS COMPLEX

D. E. Commins, C. Lemaire & S. Vanpeperstraete

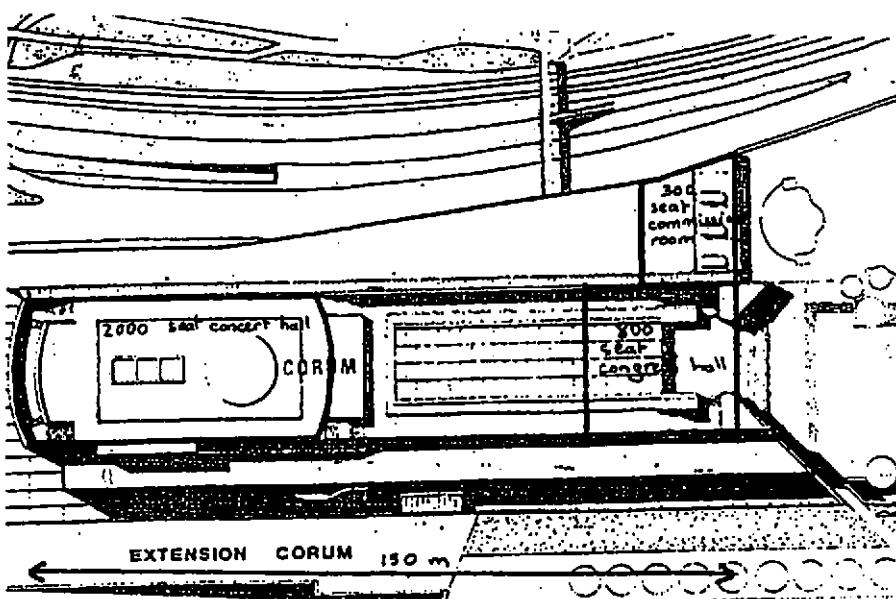
Fig 1 : Current layout plan.

'Le Corum' is a large cultural and congress centre with a 2000-seat concert hall and two conference halls : 300 seats and a 800 seats, built in Montpellier (France). The building is located close to tracks where passenger trains (including TGVs but not at full speed) and heavy goods trains are passing. Fig 1 represents a layout plan where the building and the tracks are shown.

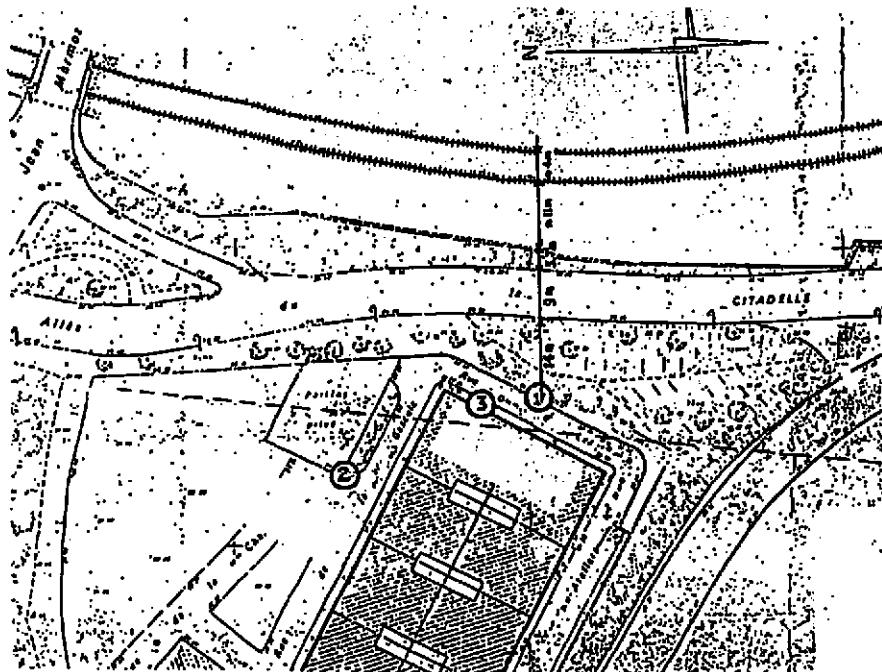
Fig 2 : Old layout plan with measurement points.

Measurements were carried out in an existing building before the construction started to see whether it was necessary to protect the building [2]. Fig 2 shows the old building and the measurement points. Vertical vibrations were measured at points 1 and 2, horizontal vibrations were measured at point 3.

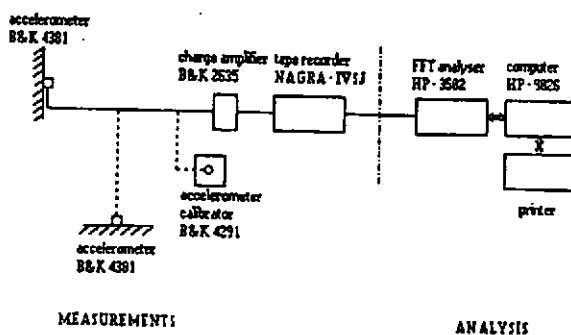
Fig 3 : Measurement and analysis block diagram.

Fig 3 shows the measurement and analysis block diagram.

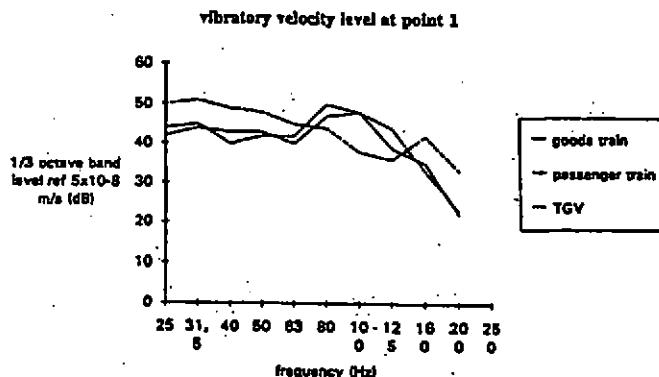
Fig 4 : Vibratory velocity levels at point 1

Table 1 gives the 1/3 octave band velocity levels in the 0-250 Hz frequency range (ref 5×10^{-8} m/s) at the first measurement point for different pass-bys and fig 4 gives the corresponding curves.

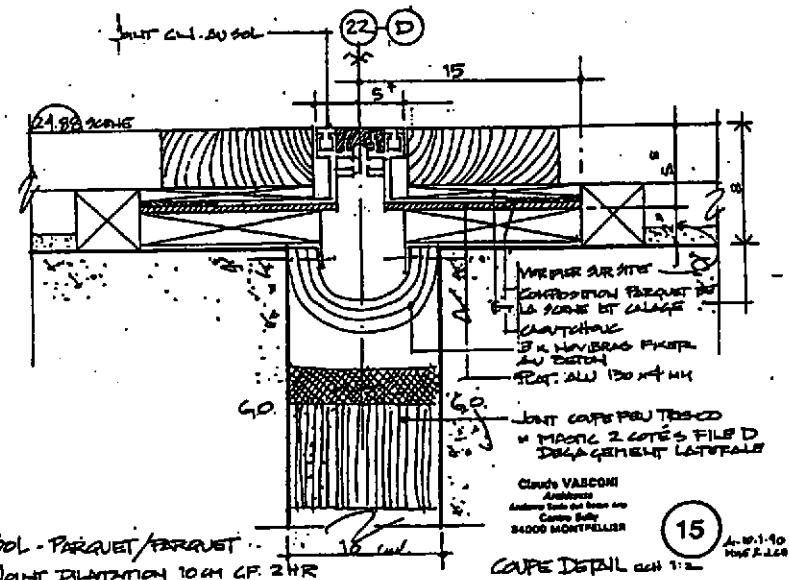
Fig 5 : Treble joint, example floor/floor

For the spring boxes to be effective, the structure of the concert hall had to be completely independent of the rest of the building. A 10 cm gap was necessary between the two independent structures. This gap had to be vibration-proof but also sound-proof and thus filled with a sound-proof joint. And for safety reasons, it had to be water-proof and fire-proof. This treble joint, of which an example is shown on fig 5, turned out to be 1600 m long.

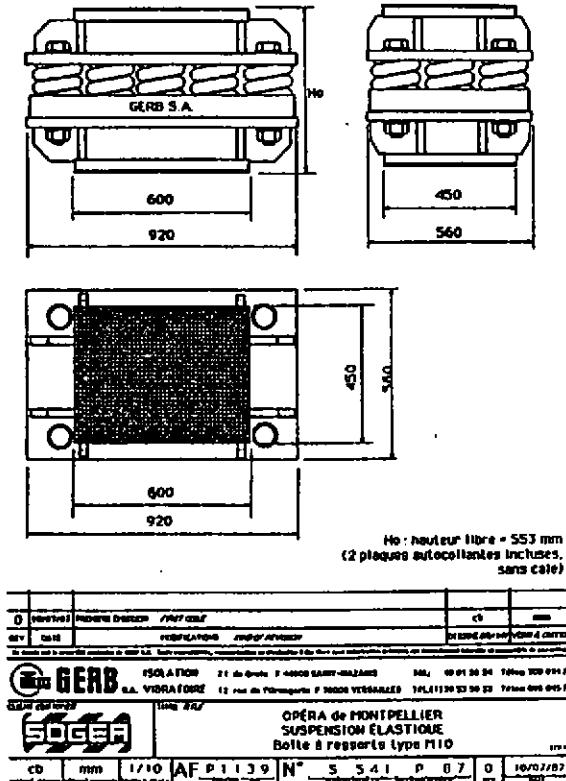
Fig 6 : Typical spring box.

Fig 6 shows an example of spring boxes.

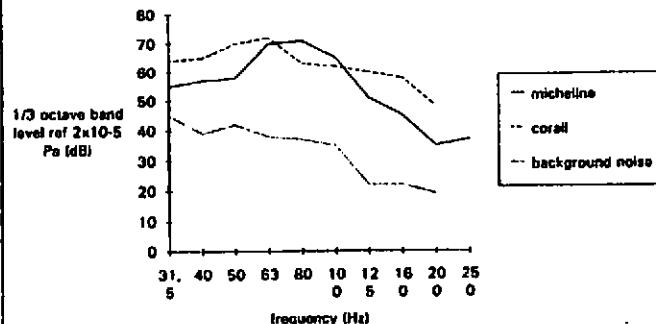
Sound pressure level in the 300 seat conference hall

Fig 7 : Sound pressure levels in the non-isolated hall.

Fig 7 and 8 show the sound pressure levels and vibratory velocity levels spectra measured in the hall. The sound pressure levels exceed the background noise level by up to 40 dB in some of the octave bands. In dB(A), the sound pressure levels exceed the background noise level, which is equal to 21 dB(A), by 30 dB(A).

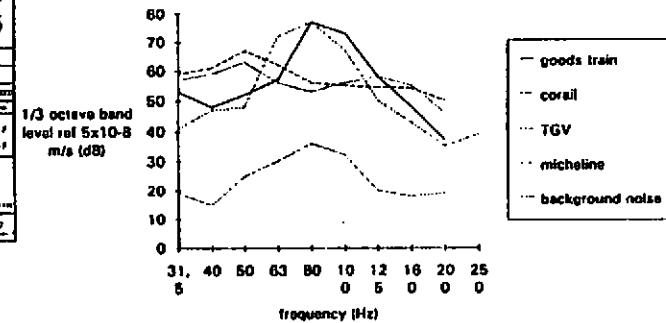
horizontal vibratory velocity level in the 300 seat conference hall

Fig 8 : Horizontal vibratory velocity levels in the non-isolated hall.

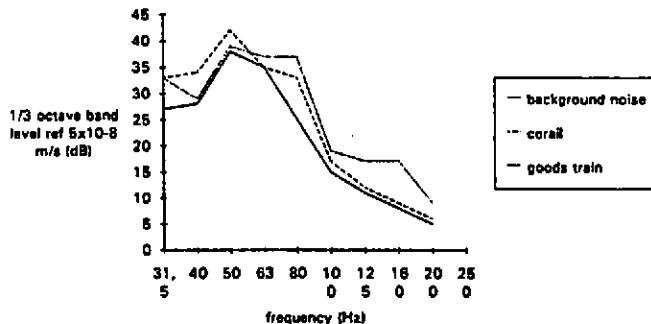
horizontal vibratory velocity level in the 2000 seat concert hall

Fig 9 : Horizontal vibratory velocity levels in the isolated concert hall.

This hall was not completed when the tests were performed. The sound pressure levels could thus not be measured. The vibratory velocity levels were measured. A comparison of the results to the 300-seat hall results is shown on fig 9 and 10.

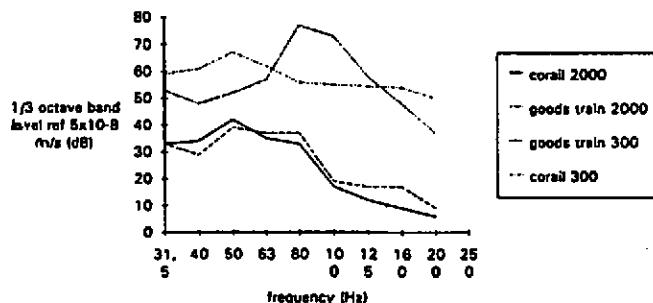
comparison of the vibration level in the insulated and in the non insulated halls

Fig 10 : Comparaison of the vibration levels in the isolated and non-isolated halls.
