AN ACOUSTIC VECTOR RECEIVER FOR WALL CONDITION ASSESSMENT IN A WATER-FILLED PIPE

J Watts Mechanical Engineering, University of Sheffield
K Horoshenkov Mechanical Engineering, University of Sheffield

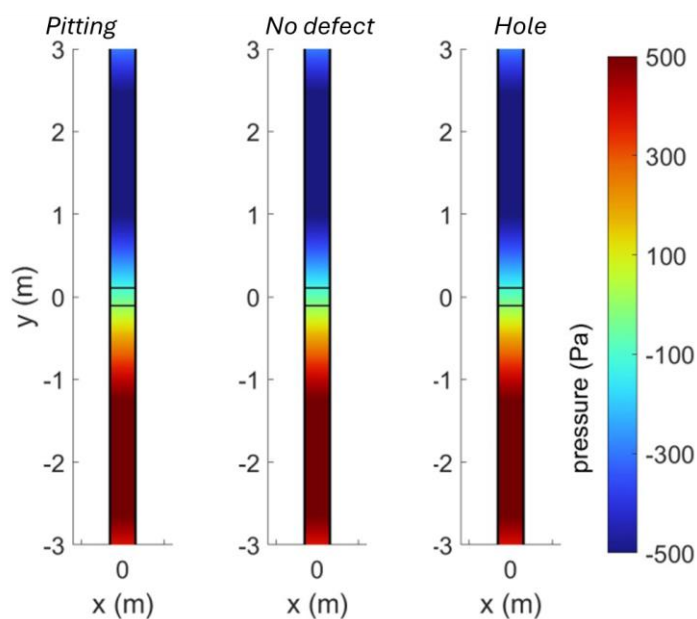
Figure 2: pressure close to defect for a plane through the centre of the pipe for models with a pitting defect, no defect and a hole defect.

Results from these models are shown in Figure 2 and Figure 3 for the response to a 170Hz source of the pressure and radial acoustic velocity respectively. It can be seen that the acoustic vector velocity is significantly more sensitive than the acoustic pressure, with a clear change in behaviour next to the defects in addition to a distinct loss of symmetry through the length of the pipe.
