# STAATSOPER UNTER DEN LINDEN BERLIN

Martijn Vercammen      Peutz, Mook, Netherlands, m.vercammen at peutz.nl.]  
Margriet Lautenbach      Peutz, Zoetermeer, Netherlands, m.lautenbach at peutz.nl

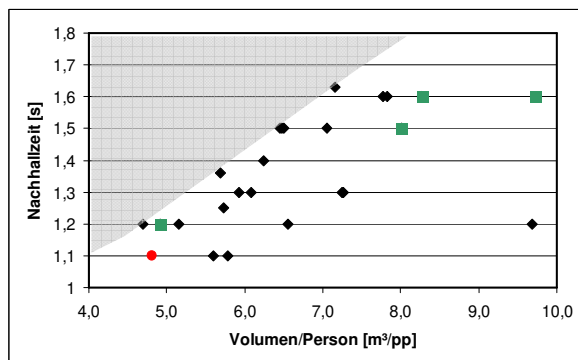
Figure 1. Measure reverberation times (1 kHz, occupied) related to the specific volume for 32 opera halls<sup>2</sup>. The green squares are opera halls that were judged to be very good<sup>2</sup>. Red: State opera Berlin.

The opera hall in 2009 had 1350 seats and a volume of about 6500 m<sup>3</sup>, this was a rather small opera, as most 18<sup>th</sup> century opera halls were small. The size didn't change over history<sup>1</sup>. Figure 1 and 2 compare this hall to other main opera halls in the world<sup>2</sup>. These show that the hall had a short reverberation time (RT) and a low specific volume. From Sabine's formula it is clear that, given an amount of absorption by each audience member, a minimum volume per person is required to obtain a certain reverberation time. The grey area in figure 1 shows that there is a maximum reverberation time related to the volume per person, above that there are no data points. Including all other sound absorption in addition to the absorption of the audience, the effective minimum absorption seems to be around 0,7 m<sup>2</sup> per person.

A specific volume of 7 m<sup>3</sup> per person would be necessary to achieve this RT in combination with a strength G of about 5 dB (figure 1), corresponding to the existing situation (figure 2).

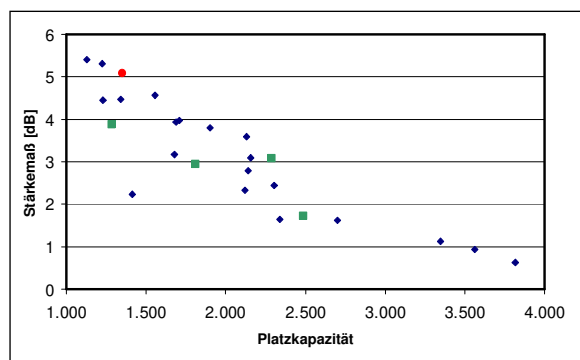
Figure 2. Strength G (1 kHz, occupied) related to the number of audience for 32 opera halls. The green squares are opera halls that were judged to be very good<sup>2</sup>. Red: State opera Berlin

The strength is mainly depending on the number of audience and is shown in figure 2. Here the strength is calculated theoretically from volume and reverberation time. Reason for that is that

published strength data is not sufficiently available and not always sufficiently reliable, since it is quite a difficult measurement regarding the calibration of the source. Based on several measurements we did in opera houses, a loss of 2 dB for energy towards the stage house is included:  $G = 31 - 2 - 10 \log(V / 24T)$  [dB]

The data show that the Berlin opera hall is relatively loud and this corresponds to the subjective impression of the authors. On the other hand, it may be so that many opera halls are not very loud, the strength is clearly below 4 dB. From an economic point of view it might be interesting to build a large opera hall, but the acoustical draw back is that it will not be loud enough. The limit seems to be around 2000 people audience.

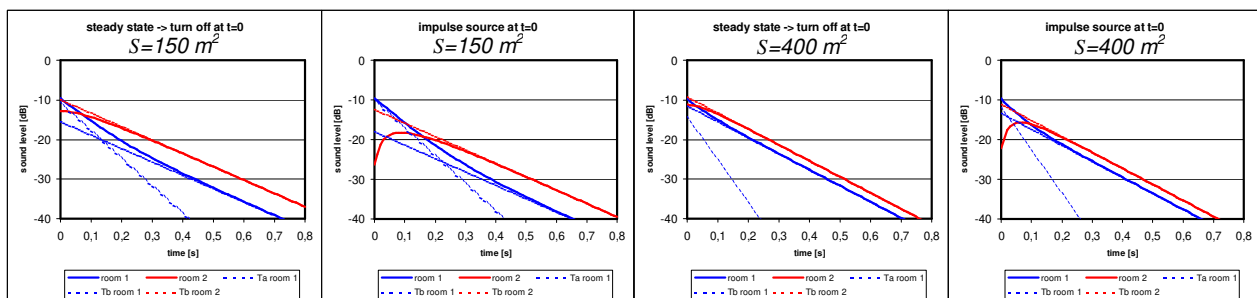
Figure 3. Diffuse field sound decay after switching off a steady state signal or after an impulse signal, room 1: 6500 m<sup>3</sup>, room 2: 3000 m<sup>3</sup>, coupling surface  $S$ : 150 m<sup>2</sup> (left) or 400 m<sup>2</sup> (right).

Figure 3 shows the decay of the diffuse field for a low and a strongly coupled secondary space, both for turning off the steady state signal as for an impulsive signal. From this study it was decided that the new volume should not be decoupled from the main hall, and therefore it was decided that the coupling surface should be maximised, the additional volume should be part of the main space.

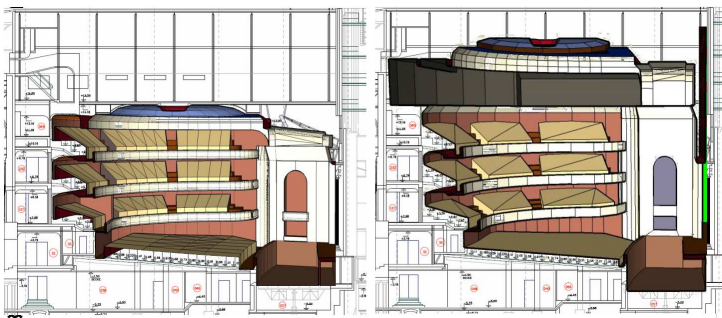
Figure 4. acoustic calculation model overlaying the longitudinal section of the hall. Left: existing before 2010, right: final design.

Figure 4 shows the 3D models of the existing hall and the final design in the longitudinal section of the building. It was possible to achieve 9300 m<sup>3</sup>. With closed fire curtain (FC) an average RT of 1,6 s. was calculated. With open curtain it depends on the stage set being used. With the set that was on stage during the measurements in the existing situation, the resulting RT's are a bit lower (fig. 5).

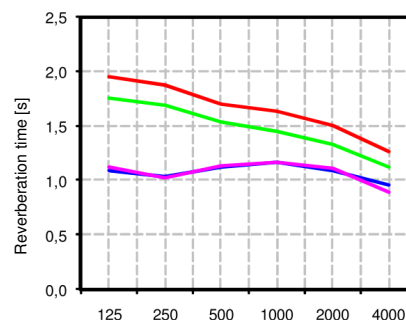
Figure 5. measured and calculated RT with audience (simulation). Violet: exiting measured FC closed, Blue: existing calculated, Red: new with FC closed, Green: new with FC open.

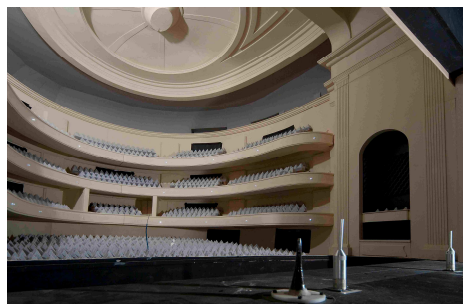
Figure 6. Scale model 1:10 with the raised ceiling and reverberation gallery. High frequency source and microphone with pre-amplifier in foreground.

In order to incorporate the wave character of sound, the initial research through calculations was extended with a scale model. A scale model 1:10 was made, details with size 10 cm, in many cases also smaller, were taken into account. Reflecting surfaces are wood with varnish, audience by pyramid foam, simulating an occupied hall, see figure 6.

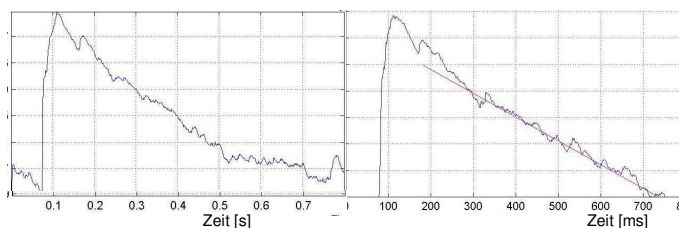
Figure 7. Measured and smoothed (20 ms) impulse response ETC from fore stage to middle of 3<sup>d</sup> balcony of existing hall (before 2010). Left: 1:1, right: 1:10. 6 dB/div.

As with the calculations, first the existing situation was examined and fitted to the measurement data and after that the new situation. Frequencies are raised according to the scale factor. Omnidirectional sources and microphones are adapted to the adapted frequency range. Contrary to the frequency the air absorption can not be scaled linear. This is compensated by a calculation algorithm. To obtain maximum stability in the impulse response (IR) the air in the model was air conditioned. Measurements were done with a MLS signal and Energy-Time Curves (ETC) were calculated. From these data parameters like clarity were calculated. Reverberation time was only considered roughly, since sound absorption data of the scale model materials is not exactly corresponding the real scale materials. Nevertheless the model showed an RT increase from 1.1 to 1.6 s. (occupied, FC closed). Figure 7 shows a comparison of the measurement in reality and in scale model. Although not completely identical, the trend is very similar.

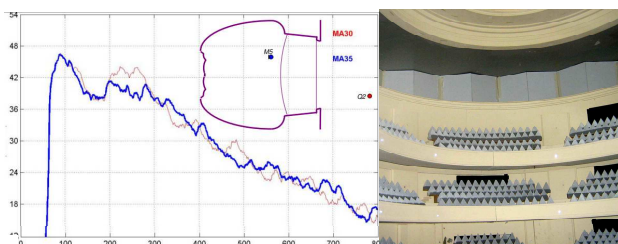
Figure 8. Measured and smoothed (20 ms) impulse response ETC from the stage to front of stalls. Left: red is with elliptical wall, blue is with folded walls.

At first instance the wall of the reverberation gallery follows the elliptical shape of the hall. Figure 8 shows that an group echo occurs at the front seats at the stalls. By introducing a folded, sound scattering structure the problem was solved.

Also visible is a gap in the IR at this position, due to lacking early reflections from the stage. This is typically something to solve with proper reflection stage sets.

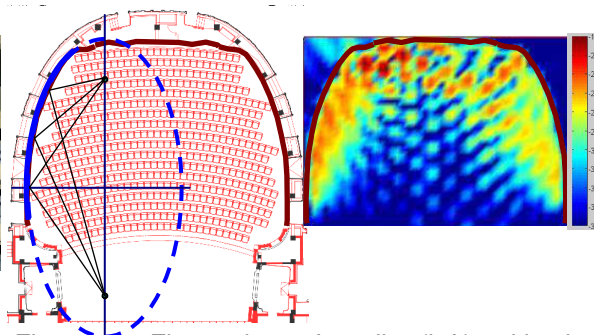
Figure 9. Floor plan of stalls (left) with the segment of an ellipse (blue) and sources and receiver points that result in focussing. Right: calculation<sup>5</sup> of the first reflection (125 Hz).

The architect that renewed the hall after the fire of 1843 made an article in 1810 about sound focussing due to elliptical ground plans in theatres<sup>4</sup>. Also the existing situation from 1955 has walls that follow the form of an elliptical cylinder. Calculations based on the Kirchhoff integral<sup>5</sup> show the first reflection with focussing areas, fig. 9. Compared to direct sound the calculated increase is 7 dB.

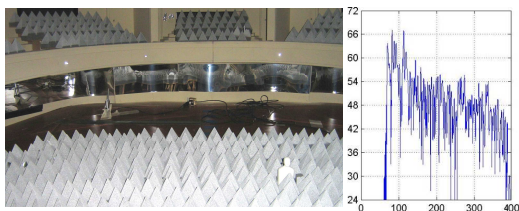
Figure 10. Left: scale model with curved mirrors on the walls, right: measured ETC in the focal point.

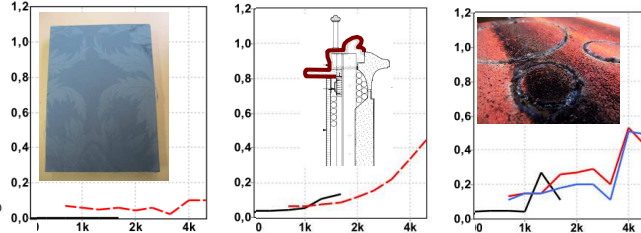
Figure 11. Measured sound absorption in the interferometer, after optimisation. Left: wall finishing (glued woven textile), middle: railings (glued velvet), right: wall above stage opening (glued velours).

The increase in reverberation time could not be obtained solely from the volume increase, since this will also increase absorbing surfaces. So the absorption of other surfaces needed to be decreased. The panels of the timber walls were replaced by heavy panels ( $40 \text{ kg/m}^2$ ) with new textile glued to the panels. Also other textiles like velvet covering of the railings and the wall segment above stage opening were optimised with sound absorption measurements on small samples (figure 11). In the existing situation there were cavities acting as Helmholtz-absorber<sup>6</sup>. These were closed. The most important sound absorbing surface however is the seating. The existing seating had a very low absorption. Acoustic objective was not to increase the sound absorption of the seats.

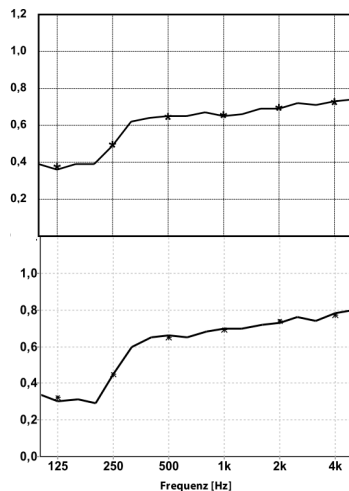
Figure 12. Sound absorption of 16 seats, measured in occupied situation. Top: existing seats, bottom: new seats.

At the same time the seating comfort should be improved, also increasing the height of the backrest with 10 cm. The improvement in seating comfort was realised with ergonomic design and a thin padding of the backrest. The increased absorption of this padding was compensated by an airtight layer in the seat. Figure 12 shows the absorption data of the old and the new seat in our acoustics laboratory: A very slight increase at high frequencies and a slight decrease at low frequencies.

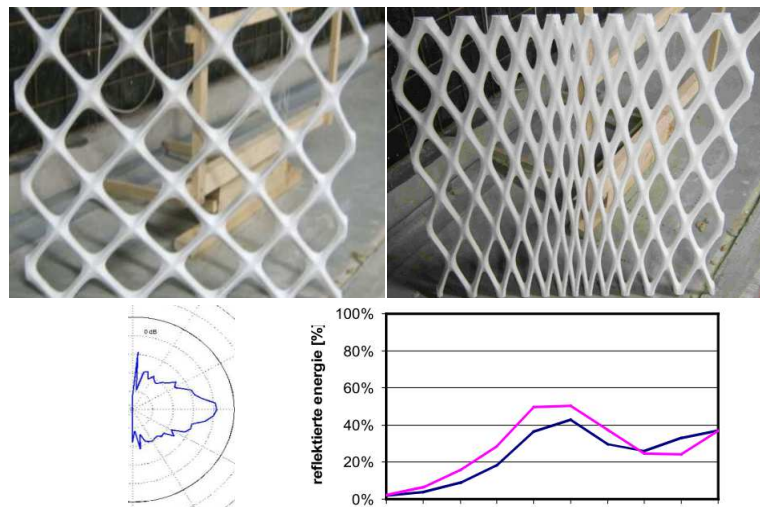
Figure 13. Measurements of the grid structure scale 1:2. Top: both samples, bottom left: directional reflection (6dB/div). Bottom right: total reflected energy [%], blue: left sample, violet: right sample.

The architect H.G.Merz has connected the original hall to the raised ceiling with a grid structure, as a reference to the original architecture with gratings and diamond motives from architect Knobelsdorff (fig. 14). This grid should be sound transparent, it should not close off the newly designed reverberation gallery. Two samples scale 1:2 of different parts of the grid were built and the directional reflection behaviour<sup>7</sup> was measured in our anechoic chamber, see figure 13. From these measurements the structure was further optimized and it was decided to fully close the upper, half open, part of the grid.

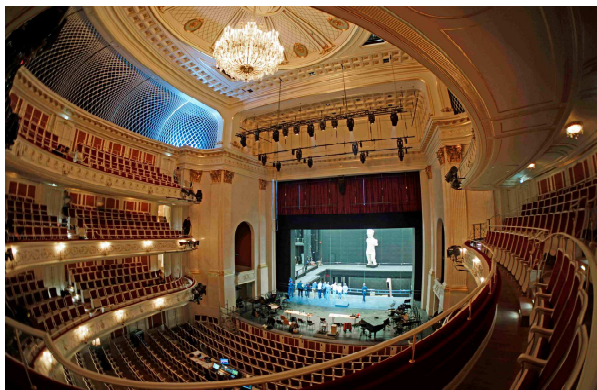
Figure 14. Photo of the renewed opera hall, september 2017

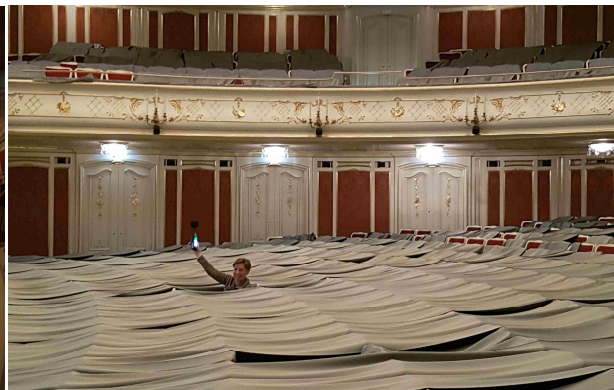
Figure 15. Stalls with audience simulation (curtains) and one of the authors with a sound level meter.

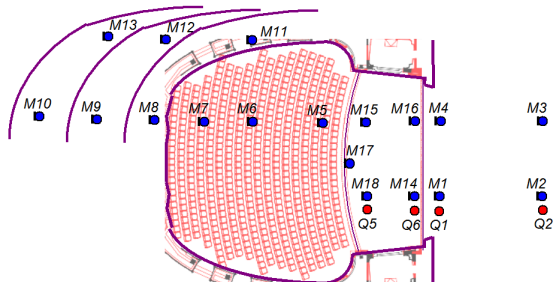
Figure 16. Sources (in red) and receivers (in blue). Balconies are schematic. Not shown: source position 7 in the pit (under Q1).

From these data the different parameters, such as clarity were derived. The 1 m positions were used to determine the strength. Figure 16 shows the source and receiver positions.

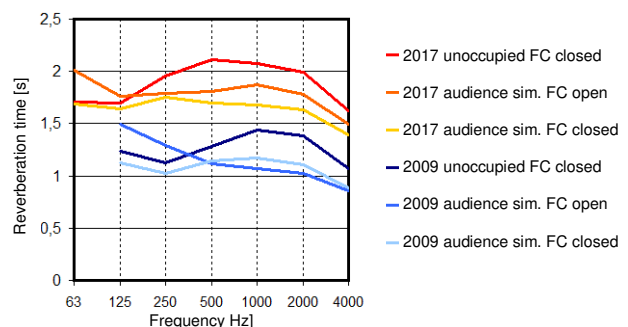
Figure 18. Measured RT with interrupted noise and pistol (63 Hz) in 2009 and 2017. Opera situation.

Figure 17 shows some examples of IR's before (2009) and after renovation (2017). The IR's from 2009, typical for drama theatres, were changed into IR's with stronger late reflections, more like concert hall acoustics. The decay curve is smooth, without disturbing irregularities. Measured RT's are shown in fig. 18. Due to the low absorption in the unoccupied hall, the RT is over 2 s. In the relevant situation, with FC closed and with audience, the measured RT(125-4kHz) is 1,6 s. and 1.7 s. at 1 kHz.

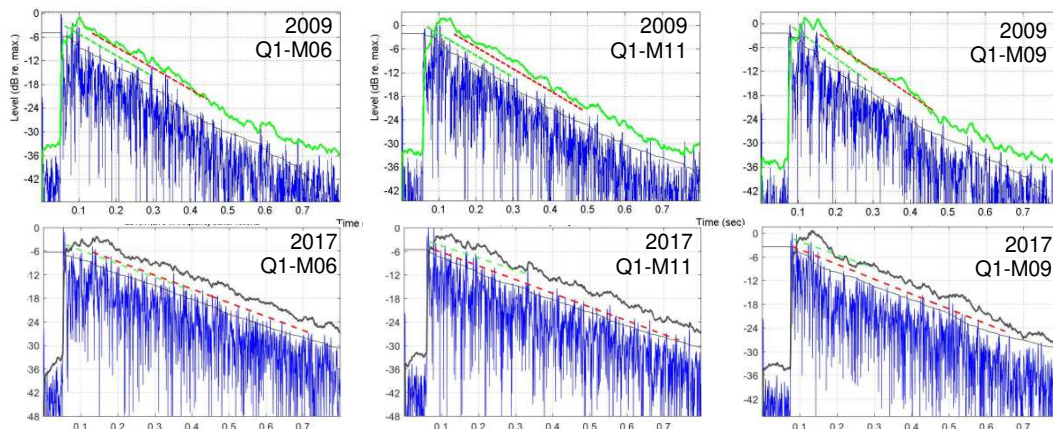
Figure 17. Some measured IR's from 2009 (top) and 2017 (bottom). Opera situation with closed FC and audience simulation.

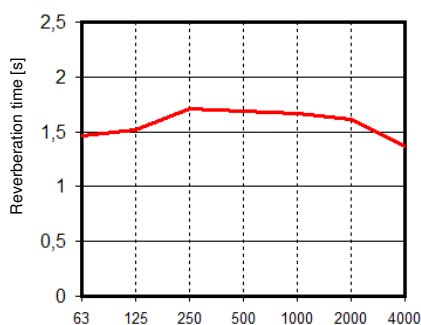
Figure 19. Measured RT with interrupted noise and pistol(63 Hz) in 2017. Concert situation

At the time of these measurements there was only the building related sound absorption in the stage house and not any curtains of the user, resulting in a longer RT with FC open. The results in the concert situation are shown in fig. 19.

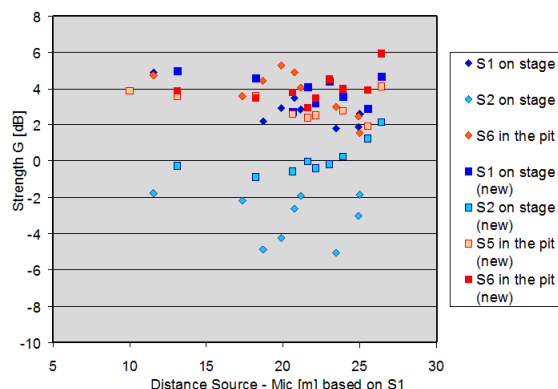
Figure 20. Measured strength G before (wybers) and after renovation (squares).

Figure 20 shows the strength in the hall. It shows the low loudness of sources on the middle of the stage (S2). The difference before and after renovation is related to the stage situation, not to the renovation. The strenght has slightly increased for the source at fore stage but is reduced for sources in the pit. This is a balance shift in favour of the singers. However this is not the case at 3<sup>rd</sup> balcony level, the level of both singers and orchestra is increased here, due to the reverberation gallery. On average a strength G is measured of around 4-5 dB, except for the 3<sup>rd</sup> balcony where it is about 6 dB. So the acoustic objective, that the hall should not become louder, is realised, with exeption of the 3<sup>rd</sup> balcony level.

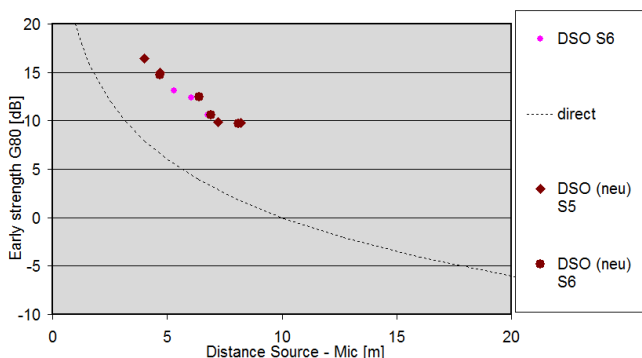
Figure 21. Measured Early Strength  $G_{80}$  before (violet) and after renovation (brown): sources and receivers in the pit

Figure 21 shows the early sound strength  $G_{80}$  until 80 ms in the orchestra pit, with sources in the pit. For comparison the decrease of direct sound under free field conditions is shown. The measurement results are about 7 dB above direct sound. The overall sound levels haven't changed much by the renovation, nevertheless the orchestra pit has totally changed, using convex panels to

decrease the strength of individual reflections, while increasing the number of reflections. The musicians indicate a remarkable improvement.

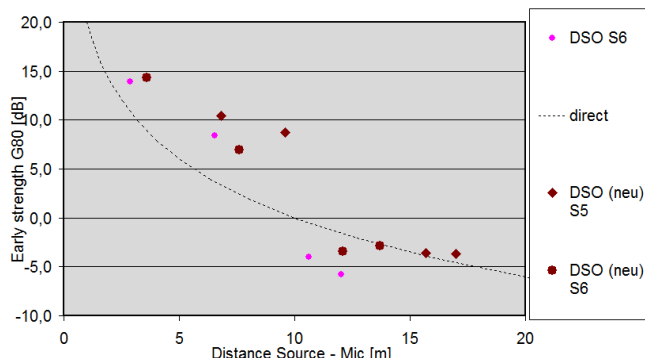
Figure 22. Measured Early Strength  $G_{80}$  before (violet) and after renovation (brown): sources in the pit and receivers on stage.

Figure 22 shows the early sound energy between pit and stage. At fore stage the audibility between singers and orchestra is excellent, but for the source 6 and positions further on stage, the direct line of sight is interrupted and sound strength drops to low levels, even under the level of (uninterrupted) direct sound. This however is typical for opera houses<sup>9</sup> and could be improved by the stage set. Also the staging can be changed, by bringing the singers more the front of the stage.
